# LAKE CARLTON HYDROLOGIC / NUTRIENT LOADING STUDY

To: Orange County Government  
Lake County Water Authority

Date: April 2018

From: Amec Foster Wheeler Environment & Infrastructure, Inc.

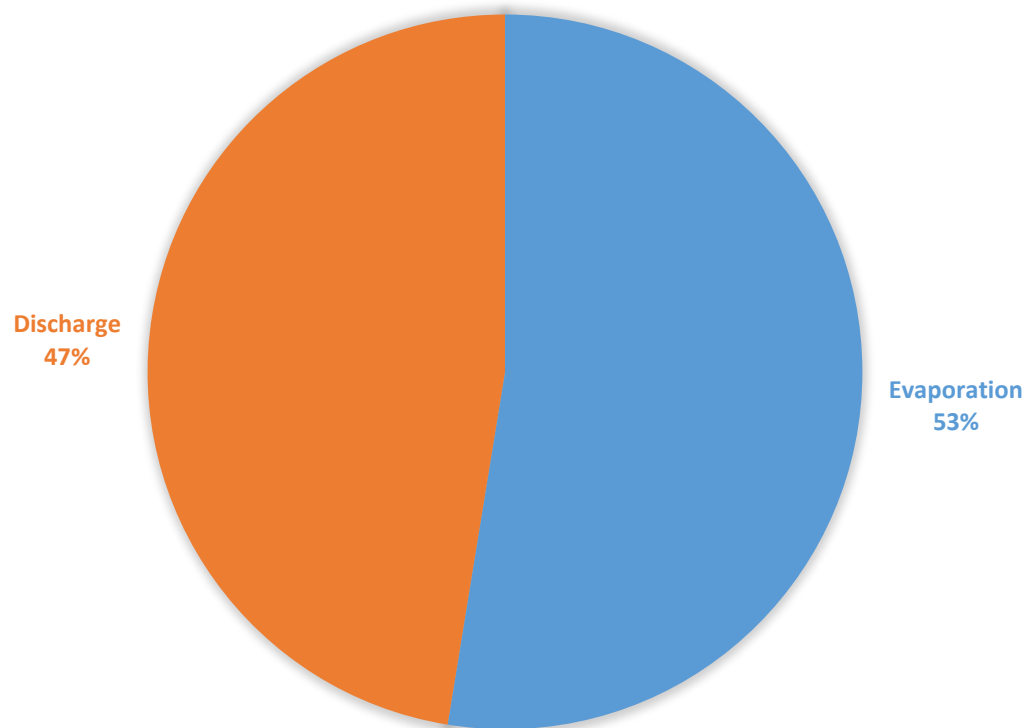
Figure 4-7. Lake Carlton Hydrologic Outputs

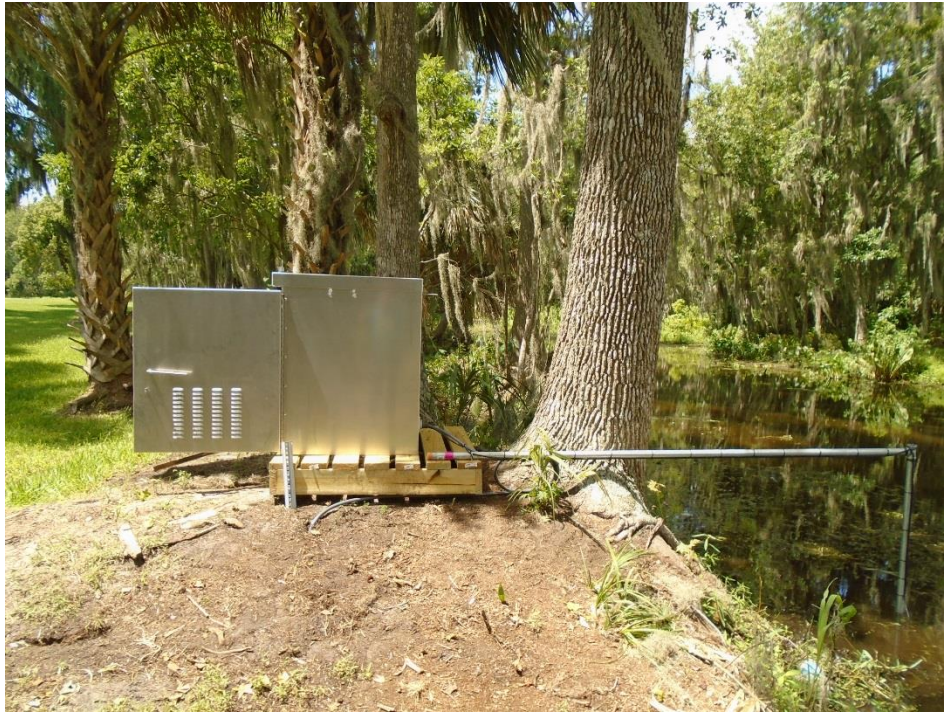
**Figure 5-4. Horseshoe Lake Discharge Sampling Location**

The Horseshoe Lake autosampler was placed near the confluence with Lake Carlton and the ADV was mounted to a steel pipe approximately five feet from the shoreline and away from direct contact with aquatic vegetation. Submersed aquatic vegetation was present at this location although shading from tree canopy prevented the vegetation from growing densely. Flow at this location was observed to routinely change direction and appears to be influenced by seiche from Lake Carlton and the super pond.
