Lake Roberts WBID 2872A Hydrologic & Nutrient Budget & Water Quality Management Plan

Final Report

September 2015

Orange County, Florida

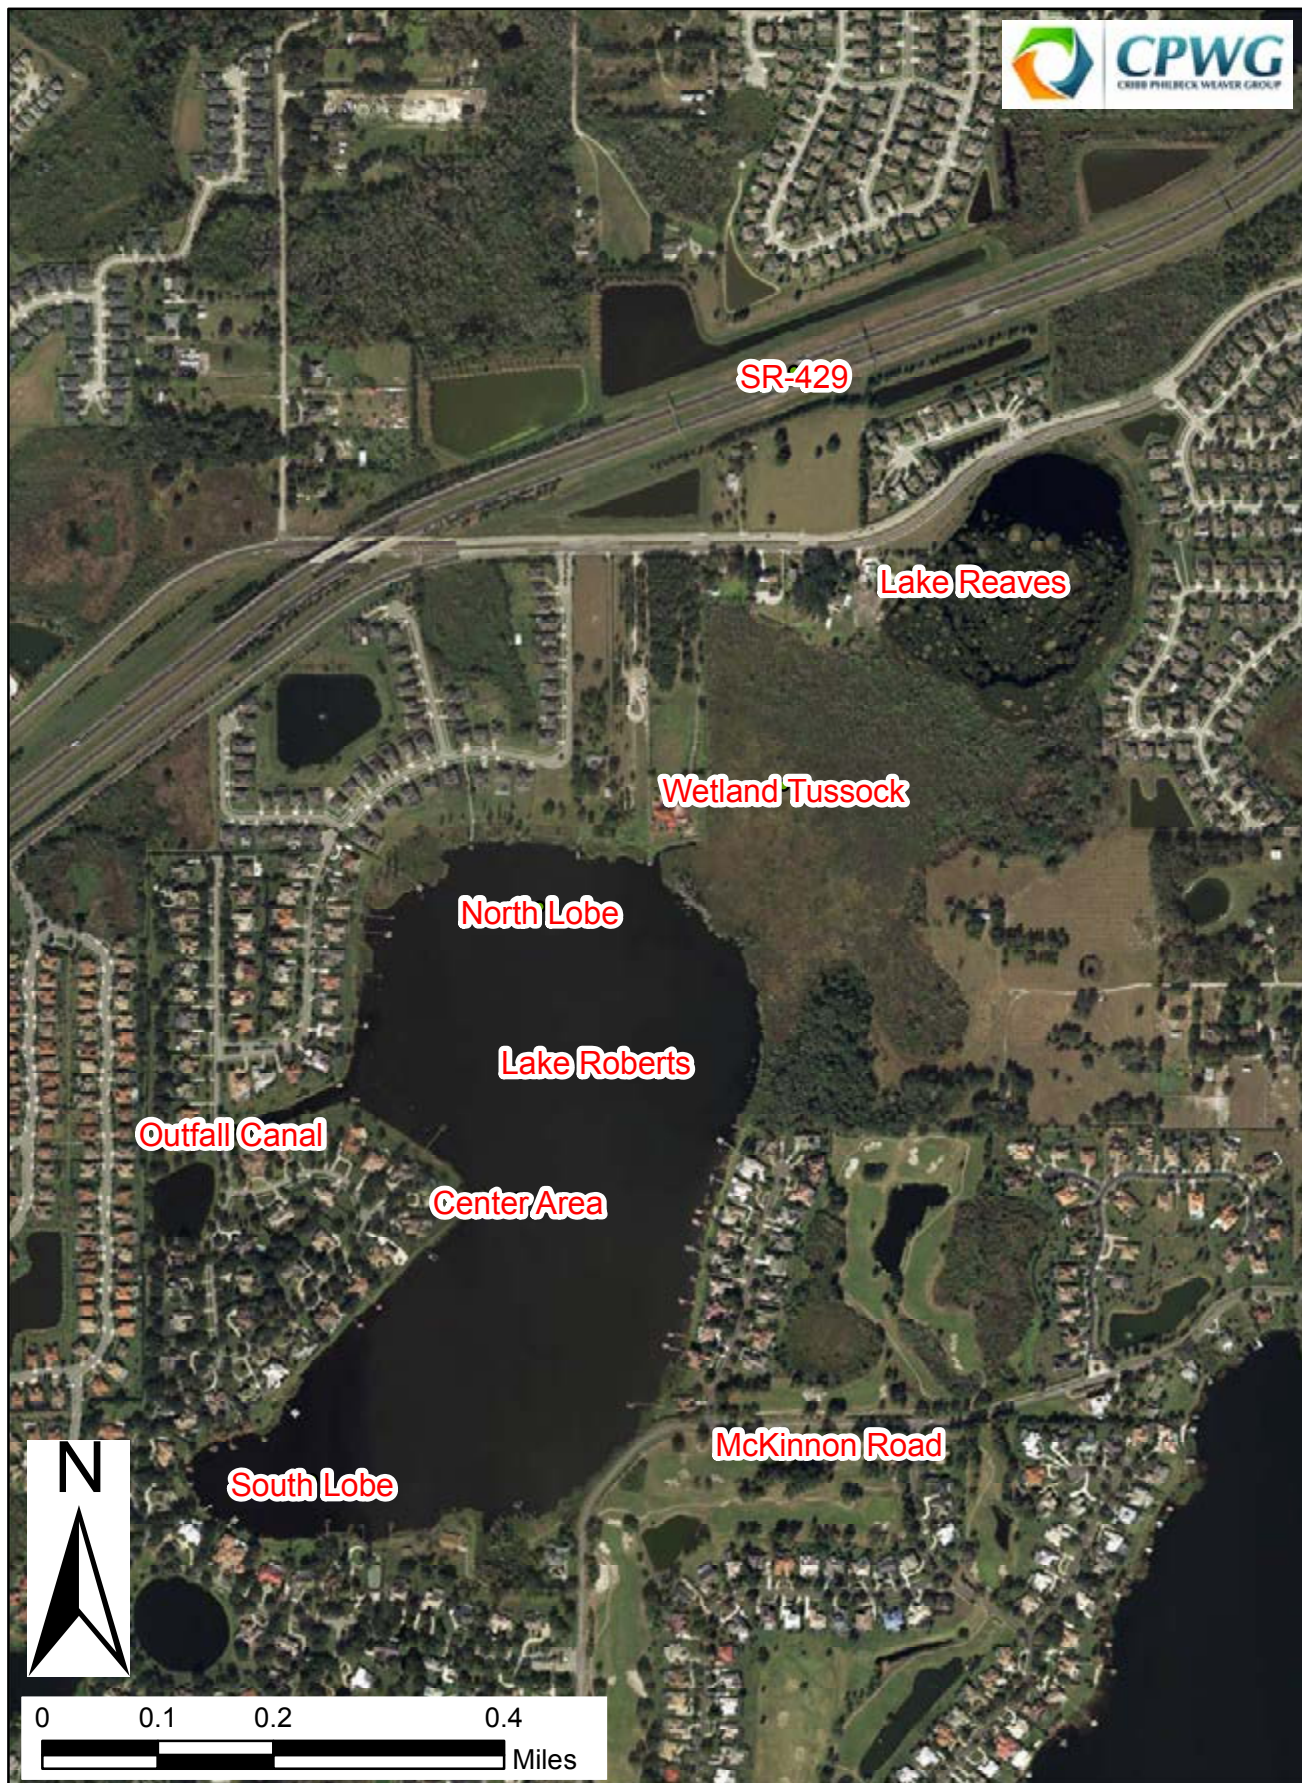
An aerial view of Lake Roberts and the surrounding area is shown in Figure 2-1. Lake Roberts is shaped similar to an hourglass with distinct north and south lobes. A wetland tussock is located along the northeast border of the lake connecting Lake Roberts and Lake Reaves. The general nomenclature illustrated in Figure 2-1 is used throughout this report to describe areas within the lake.

Lake Roberts General Overview Map

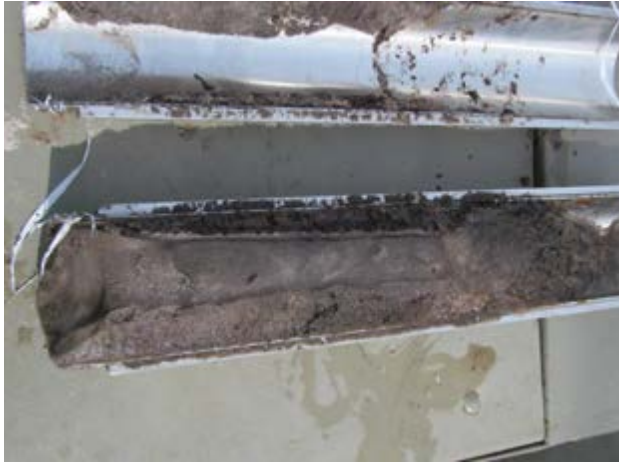
Photograph of Sandy Sediments
SS-10

Visual characteristics of sediment core samples were recorded for each of the 22 sediment samples collected in Lake Roberts during April 2014. A summary of visual characteristics of the sediment core samples is presented in Table 2-5. In general, 15 sediment samples were collected near the perimeter of lake (in conjunction with FDEP) and 7 sediment samples were collected in the deeper areas of the lake (north and south lobes). A surficial layer of unconsolidated organic muck was observed in 4 of the 15 shallow sites with measured depths ranging from 0-5 cm. Three additional shallow sites had mucky mottling in the surficial layer of sediment. A surficial layer of unconsolidated organic muck was observed in 6 of the 7 deep sites with measured depths ranging from 0 to 20 cm. The organic muck at the shallow sites included root mass and detritus. In deeper portions of the lake, the organic muck appears to be more consolidated beneath the surficial layer, with a consistency similar to pudding. These layers, which reflect older organic deposits that are resistant to further degradation, are referred to as consolidated organic muck and typically do not resuspend into the water column except during relatively vigorous wind or boating activity on the lake. Shallow and shoreline areas of the lake are characterized by various types of brown fine sand which is the parent soil layer which forms the original lake bottom. Photographs of some of the sediment characteristics are shown below.

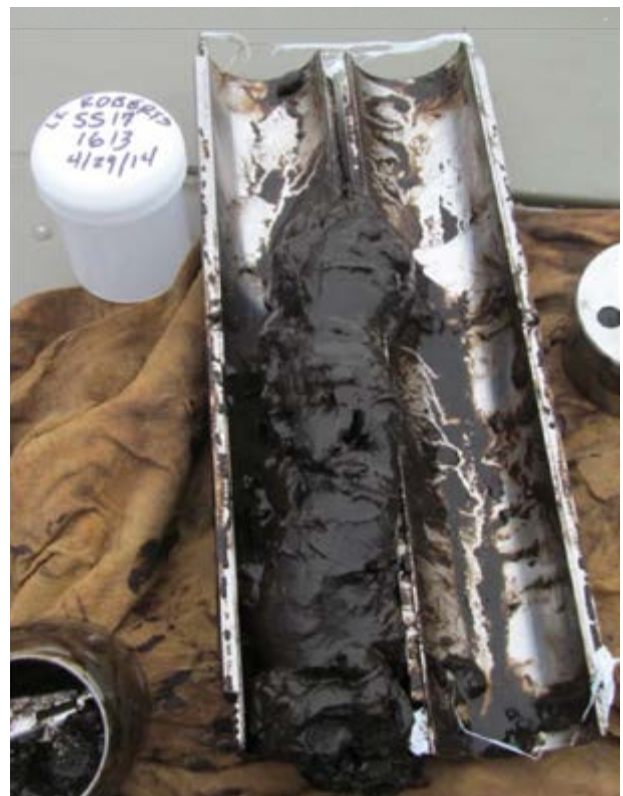
Photograph of Muck Sediments
SS-17

Photographs of Sediment Characteristics in Lake Roberts

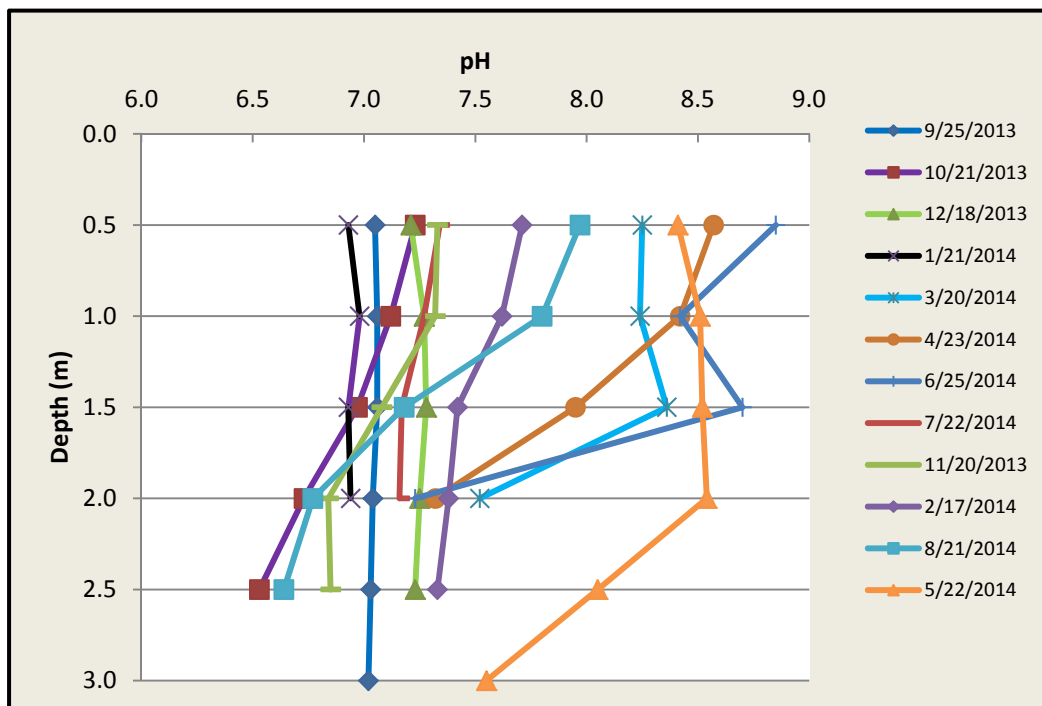
Figure 2-25A. Vertical Field Profiles of Temperature, pH, Conductivity, and Dissolved Oxygen Measured at the North Lobe in Lake Roberts from September 2013-August 2014.

Measured conductivity values were relatively uniform throughout the water column during the monitoring events. Increases in conductivity were observed during the warmer months.

Dissolved oxygen concentrations were collected during each of the monitoring events to a depth of approximately 2-3 meters, depending upon sample date. Surface concentrations appeared to be uniform to 1 meter below the surface and then generally decreased with increasing water depth. Only one sampling event showed concentrations reaching anoxic conditions at the water-sediment interface. It appears that there is minimal internal recycling occurring in this area of the lake.

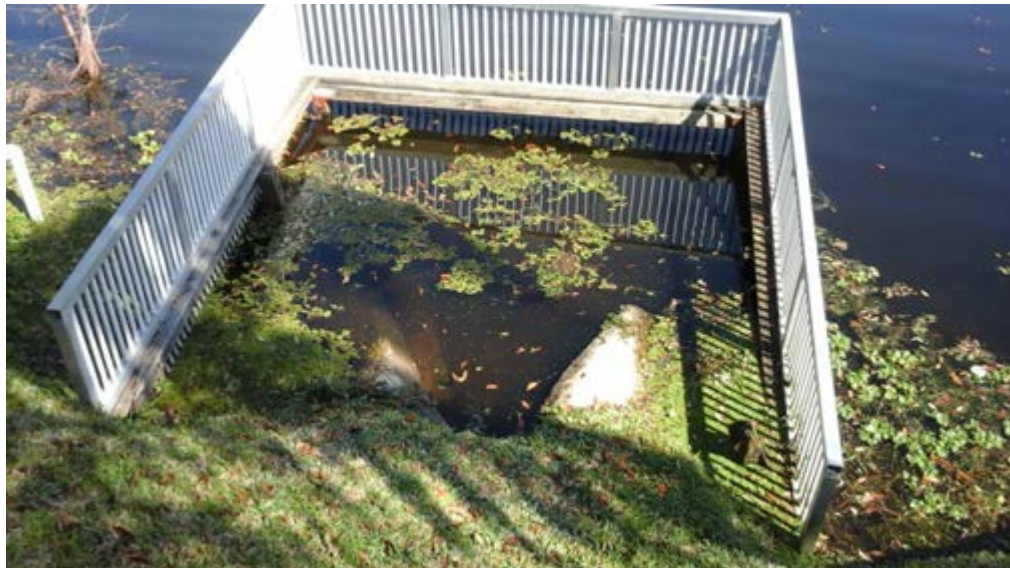
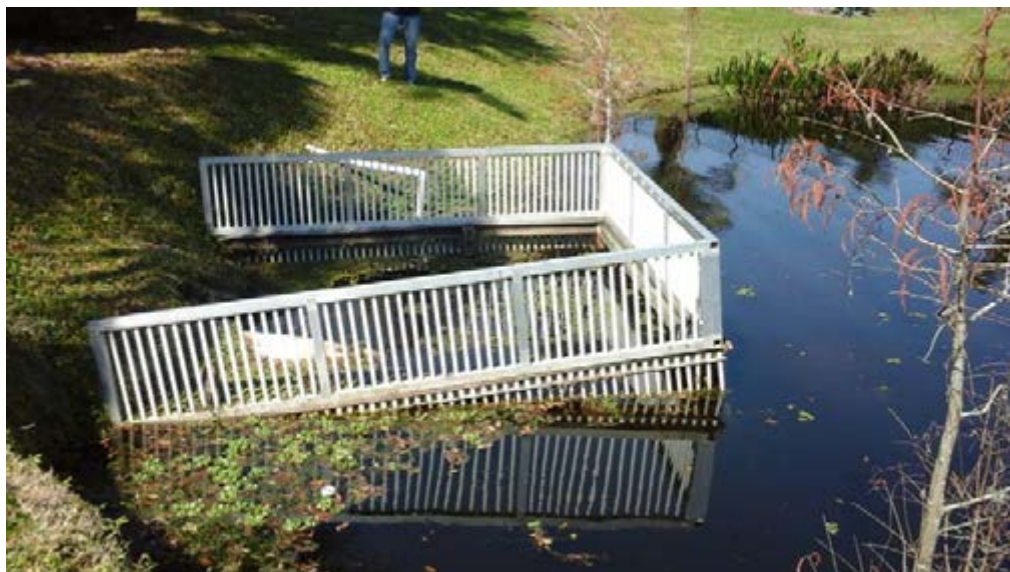
Discharge from Lake Roberts is regulated by a high point in the outfall pipe at the end of the outfall canal located on the west side of the lake. A photograph of the outfall structure is presented on Figure 2-34. The outfall structure consists of a 45"x 28" ERCP at elevation 106.8, NAVD. The outfall pipe is surrounded by a fish gate that does not impede flow. Further downstream of the outfall pipe, the invert in the drainage system rises to elevation 109 feet which appears to control the water level in Lake Roberts. The wetland area at the outfall of the drainage system appears to have an elevation between 109 and 110 feet. Therefore, for purposes of estimating the outfall volume of Lake Roberts, a 1-foot long weir at elevation 109.75 is assumed.

Figure 2-34. Outfall Structure for Lake Roberts with fish gates

Discharge from Lake Robert is regulated by a high point in the pipe system downstream of the outfall pipe which flows west from the outfall canal located on the northwest side of Lake Roberts. A photograph of the outfall structure is shown on Figure 2-34. The outfall structure consists of a 45"x28" ERCP at elevation 106.8, NAVD. The outfall pipe is surrounded by fish grates that do not appear to impede flow. Downstream of the outfall,

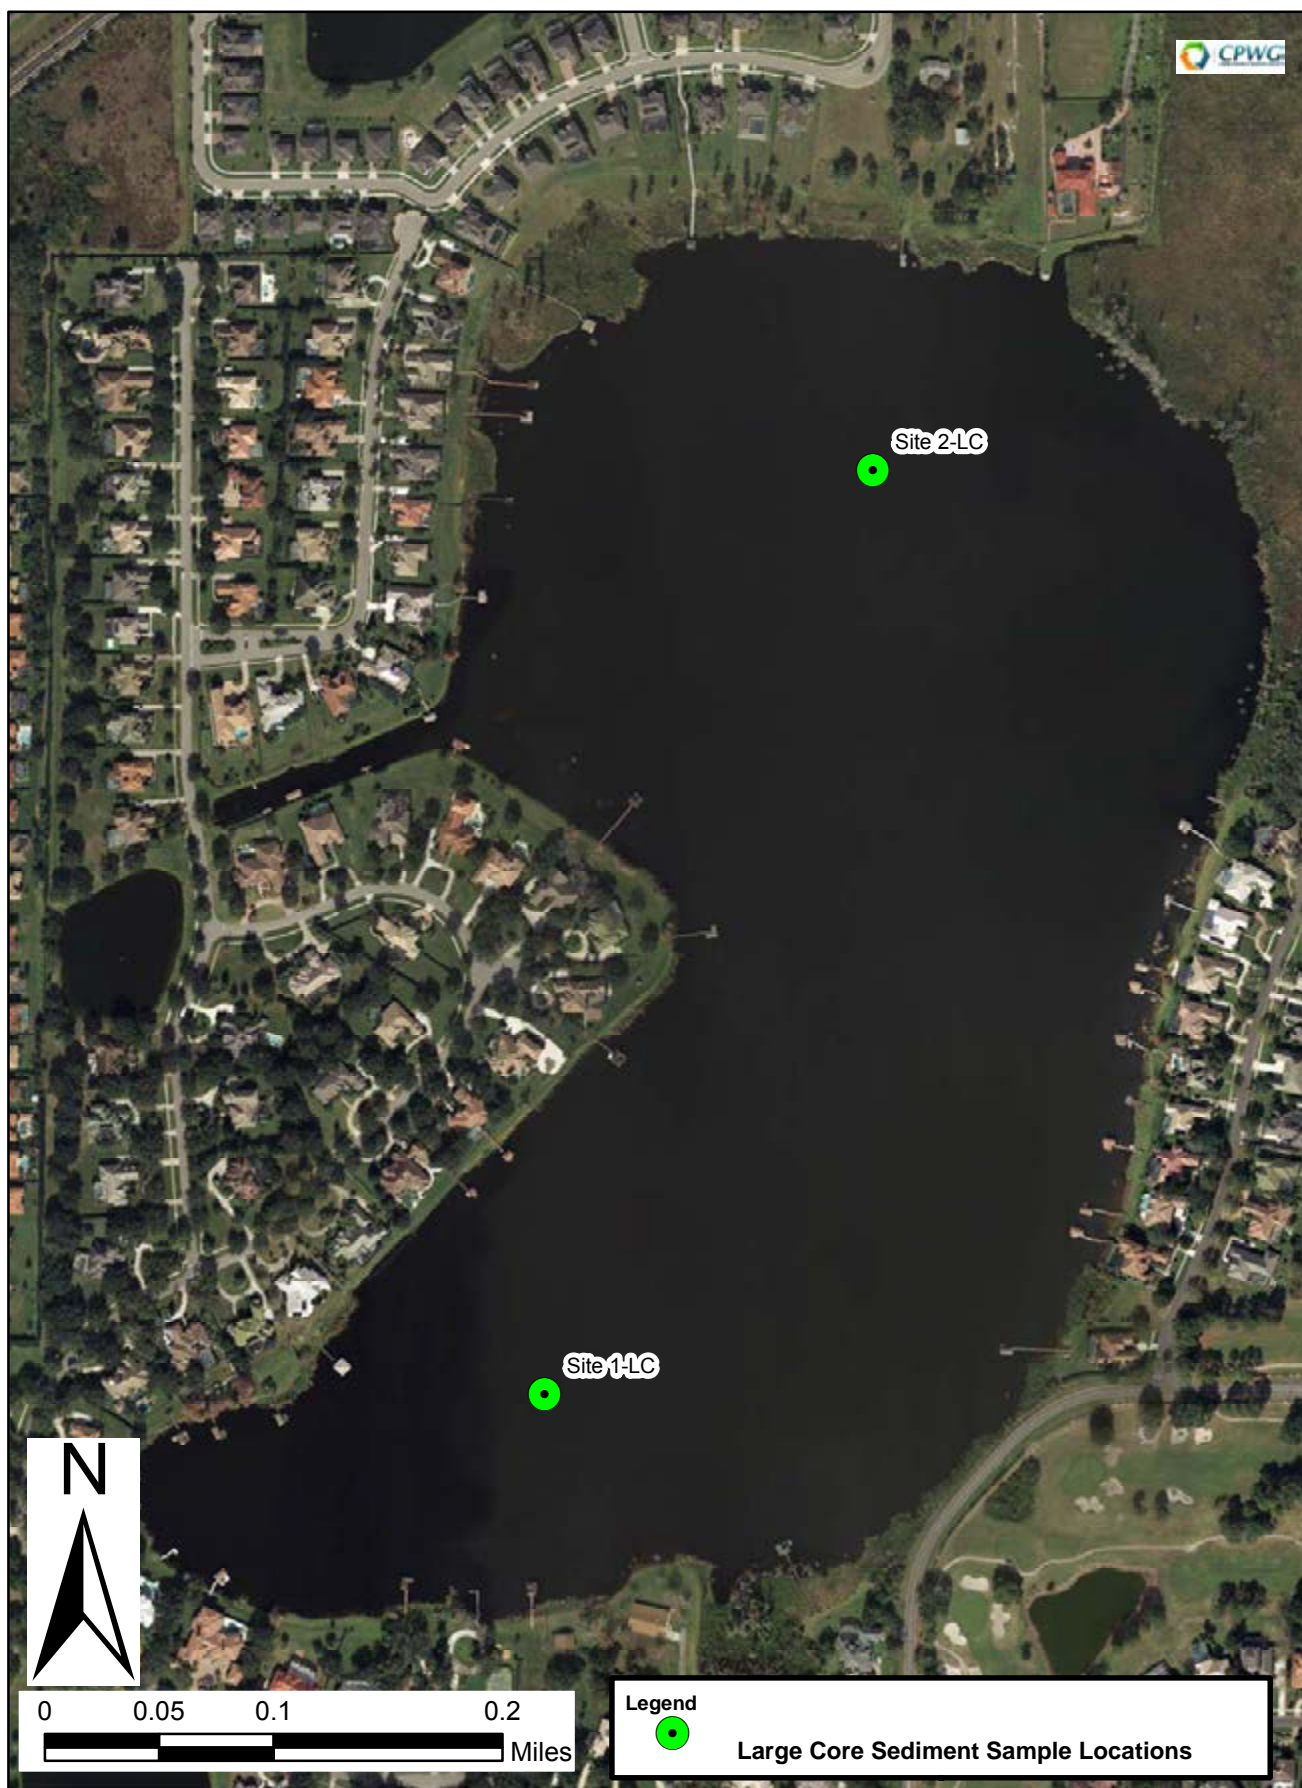
Sites for the Large Diameter Sediment Cores
Used in Incubation Experiments

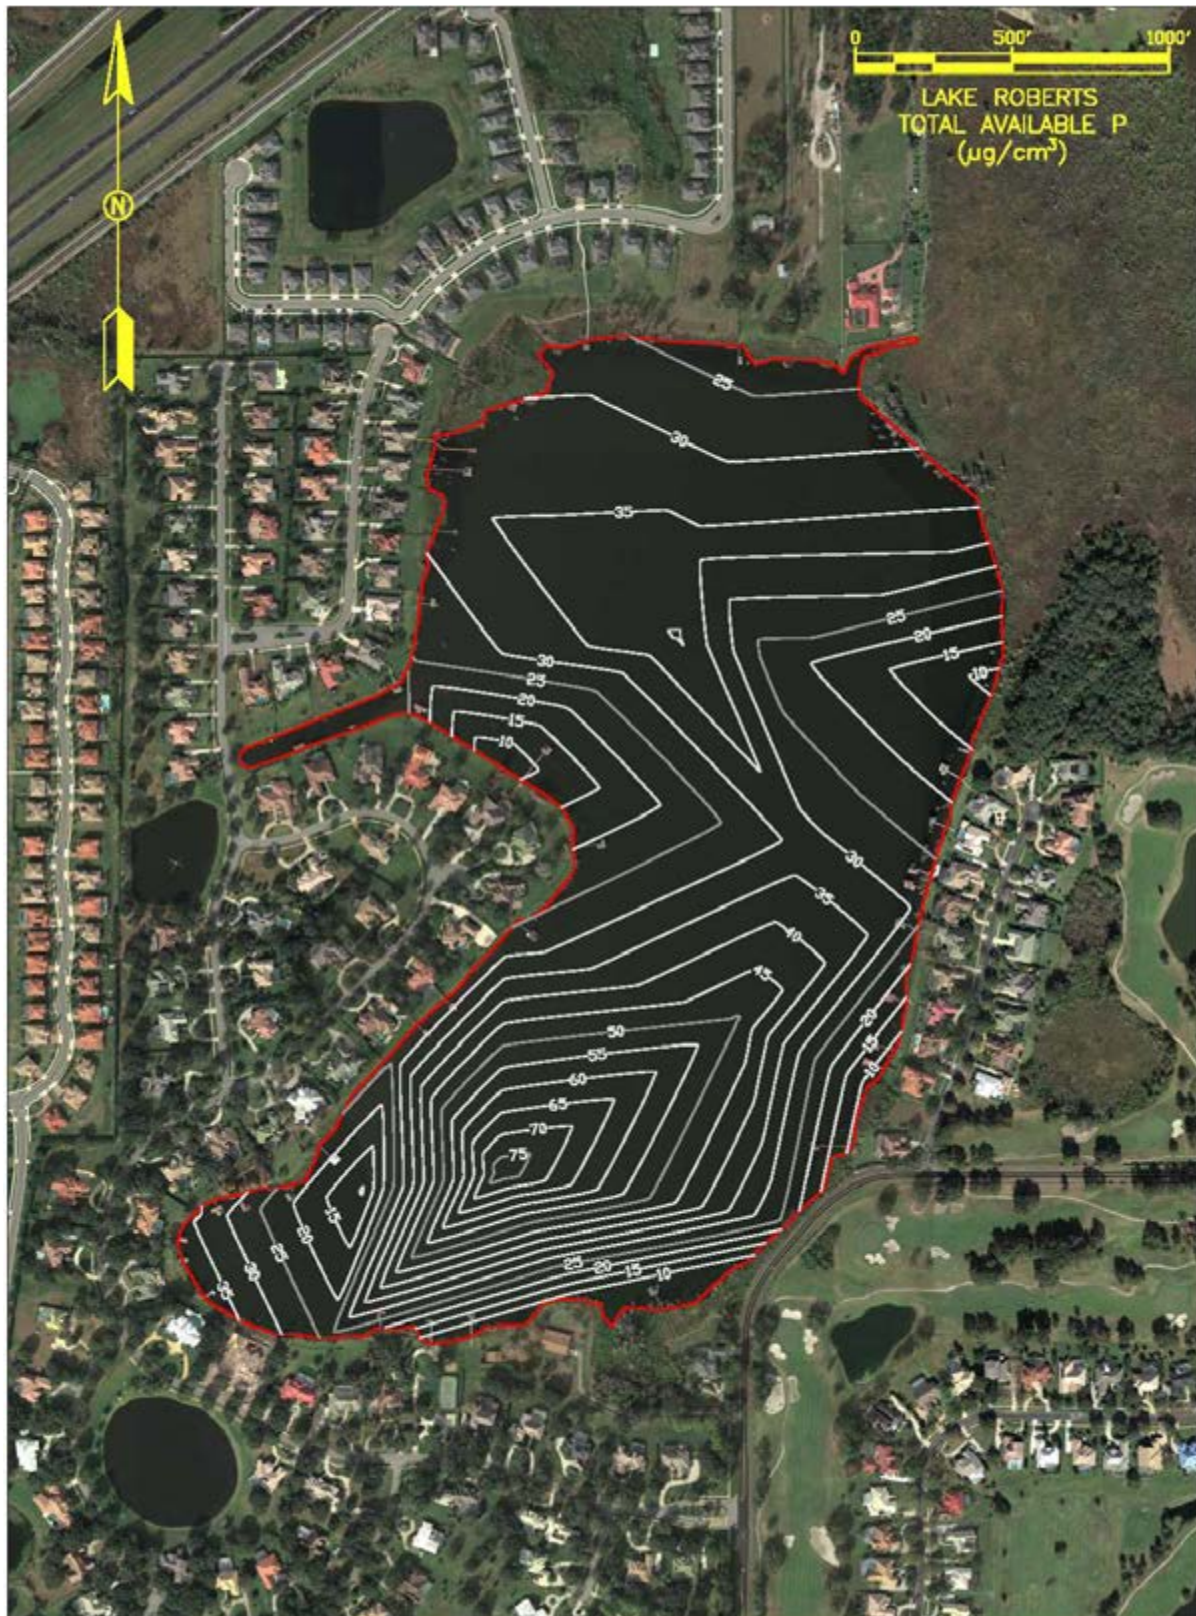
Figure 6-1. Isopleths of Total Available Phosphorus ($\mu\text{g}/\text{cm}^3$) in the Top 10 cm of Sediments in Lake Roberts.

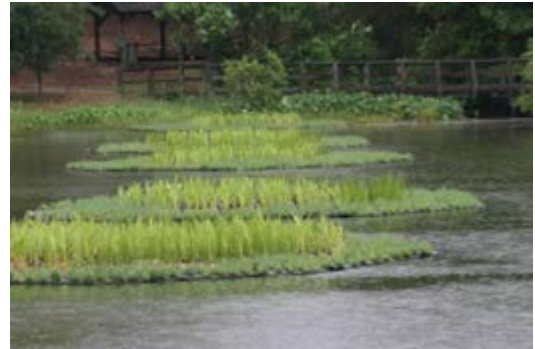
Most of the treatment of nutrient rich water within a wetland occurs in the thin aerobic layer at the surface of the soils within plant communities. This aerobic biofilm is a result of oxygen leakage from the plant roots at the soil-water interface. In an effort to more efficiently utilize the natural ability of macrophytes to extract and store nutrients from surface water, a floating mat system to suspend native emergent plants and grasses is designed. By expanding the root zone that is in contact with the water column the thickness of the aerobic layer is increased, resulting in increased nitrification and accelerating the process in which nitrogen is cycled from the aquatic environment to the atmosphere. The greatly expanded root mass also facilitates increased uptake and storage of inorganic phosphorus in the plant tissues by creating more surface area for beneficial bacterial colonization.

Through the periodic removal of mature macrophytes from the floating plant mat, one prevents the accumulated nutrients from re-entering the aquatic ecosystem at senescence. Those plants are then composted at an upland location, allowing bacterial decomposition to release some of the organic phosphorus so it can be recycled and used as a fertilizer ingredient for growing soil mixtures. The foam and nylon parts of the floating plant mats are re-used to start a new cycle of plant growth and nutrient uptake. Beemats is one company that provides floating wetland mats.

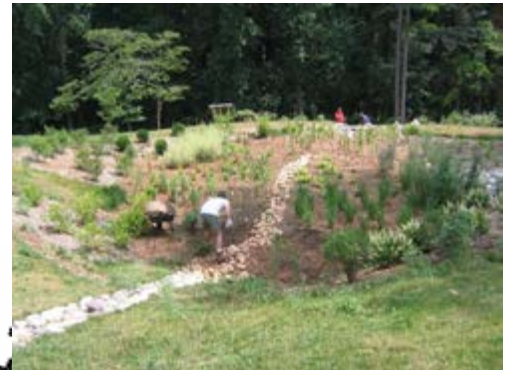
Use of a bioretention area requires surface runoff to be directed into a shallow landscaped depression. The primary component of bioretention is the filter bed, which is typically comprised of a mixture of sand, soil, and organic material as the filtering media with a

Illustration: Typical Bioretention Area

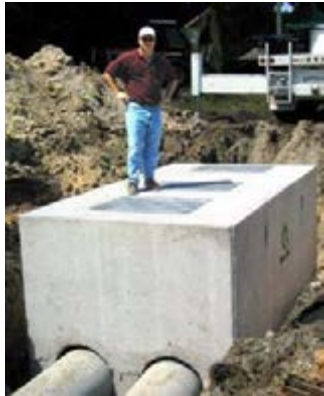
baffle boxes DEP currently allows the use of the following removal efficiencies for grant applications and other uses: 16% for TP and 19% for TN. Similar to the inlet baskets, Bold and Gold or other media can be added to baffle boxes to increase their nutrient removal capabilities. The capital cost to add Bold and Gold is estimated at \$6,000 per baffle box. The 2-3 cubic yards of the media in the baffle box would require replaced every five to seven years at an estimated cost of \$5,500.
