CURRENT BIOLOGICAL HEALTH AND WATER QUALITY
OF
THE ECONLOCKHATCHEE RIVER AND SELECTED TRIBUTARIES
January and July 1999

Surface Water Monitoring Section
Florida Department of Environmental Protection
Orlando, Florida

April 2000

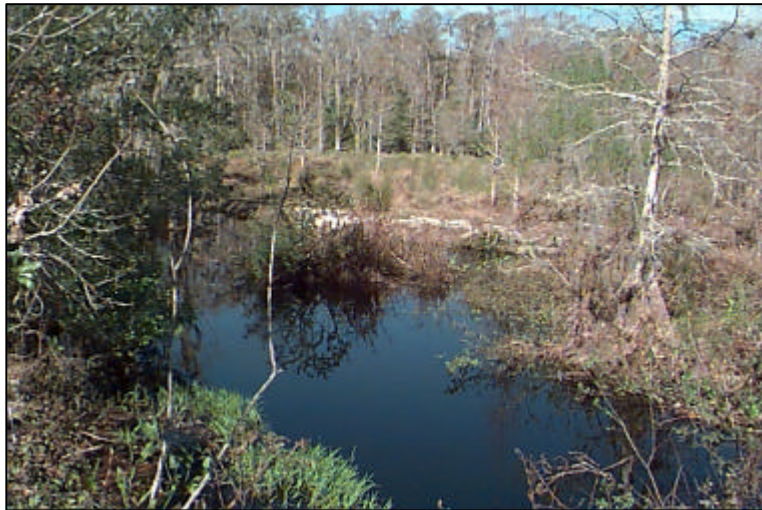
Econlockhatchee River at the Beeline Expressway (SR 528)

Immediately above the SR 528 bridge, the Econ is joined by Little Creek from the east, as well as by Disston Canal less than two miles farther upstream. At the Beeline, the river hydrology has been disturbed by construction of the expressway bridges. This site was monitored for fecal and total coliforms only. Coliform bacteria levels were found to be very high in January (fecals 940 colonies/100mL and totals 1000 colonies/100mL). The fecal coliform count of 940 is a violation of Class III water quality standards. Coliform

concentrations were somewhat high in July (FC 155, TC 1800). These values are most likely a reflection of the land use (cattle ranching) in the watershed upstream of this site.

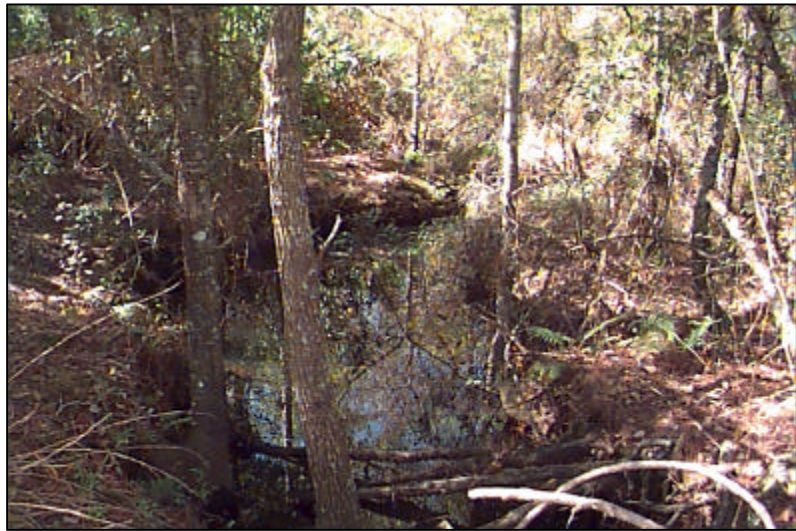
Reynolds Parkway Canal is the southernmost of four canals sampled which drain the Wedgewood (a.k.a. "Rocket City") subdivision in eastern Orange County. Sampling was not actually carried out within the wide, terraced, constructed sections of this and the other canals, but rather in the small, more stream-like outflows where the canals enter the Econ River.

Data from biological sampling in January 1999 indicate that the Reynolds Parkway Canal outflow supports a healthy and well-balanced macroinvertebrate community. Twenty-one different aquatic invertebrate taxa were found in the biorecon. This number included a total of 7 mayflies and caddisflies (EPT group). The site scored 15 on the Florida Index. All three metrics passed target thresholds for healthy streams in the Florida peninsula.

All physical and chemical parameters measured were at normal levels. Nutrients and metals concentrations were low on both sampling dates. The only elevated level found was for biological oxygen demand, which was slightly to moderately high. This might have been a result of large amounts of organic matter present in the canal proper upstream. However, no depression of dissolved oxygen levels (and thus no violation of water quality standards) was detected on either sampling date.

From the standpoint of aquatic habitat, the site was rated as suboptimal, with a score of 116 out of a possible 160 points, or 73%. The lower marks here are largely a result of the absence of some habitat types, low water velocity, and smothering of some habitats by silt.

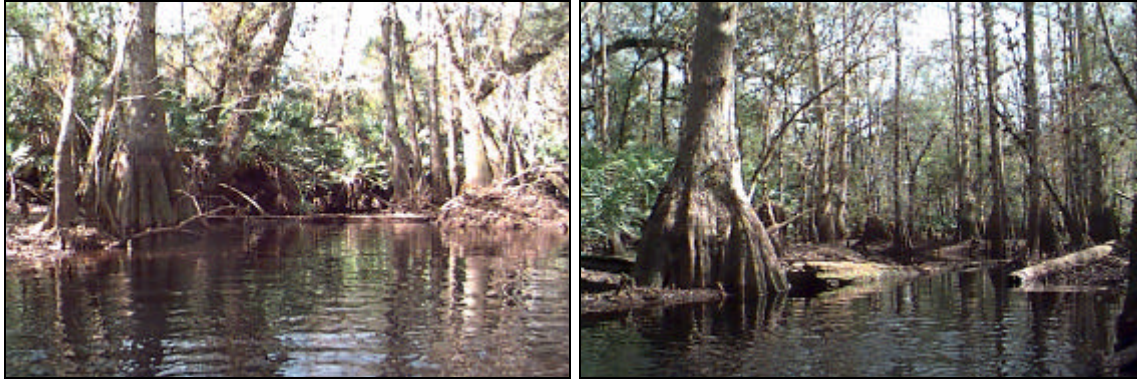
Econlockhatchee River upstream of Quarterly Parkway Canal

The next site downstream was the Econ River itself approximately 50 m upstream of Quarterly Parkway Canal. This area of the river is particularly scenic, with abundant animal and plant life. A number of large cypress trees, such as the one shown in the right-hand photo below, remain in this part of the Econ.

The Econ River in this area supports a healthy and diverse macroinvertebrate community. Biorecon sampling yielded 28 different kinds of aquatic invertebrates, including 8 EPTs (4 mayflies and 4 caddisflies). The Florida Index value was 16. The habitat assessment score was in the optimal range, with 130 out of 160 points scored.

Nutrient levels in the Econ were low, with the exception of Kjeldahl nitrogen (TKN), which was fairly high in one instance (1.4 mg in July 1999). Low concentrations of the five metals tested for (copper, lead, manganese, nickel, and zinc) were found on both dates. Coliform bacteria levels, however, were quite high in January (fecals 720/ 100mL and totals 2000/ 100mL). Neither measurement, however, indicated a violation in water quality standards for a single sampling event. Since coliform bacteria levels were low in Reynolds Parkway Canal, it is likely that the source of these high coliforms is upstream of the Beeline Expressway.

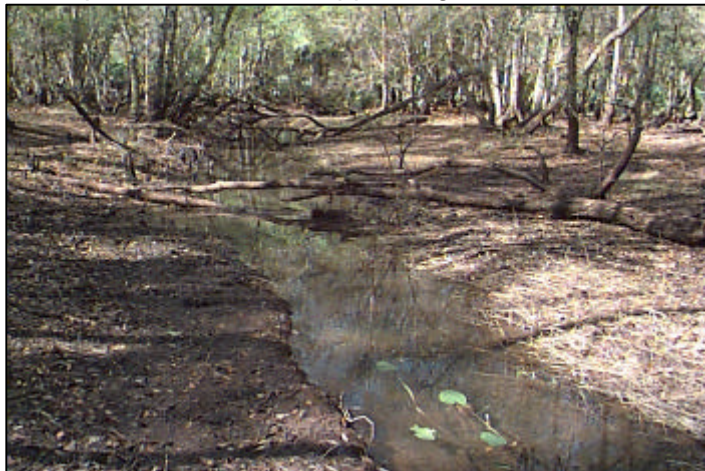
Unlike the other canals sampled, the outflow from Quarterly Parkway Canal is short, because the river at this point curves to the east toward the end of the canal. Thus the outflow is not developed into a natural-appearing stream like the others, but instead resembles a shallow

ditch. Its aquatic biological community, therefore, was not as diverse as that seen in at the other sites. It was still healthy, however, with 19 total taxa, 4 of which were mayflies and caddisflies (EPT group). The Florida Index score was 16. The most abundant macroinvertebrates in the sample were the caddisfly *Cheumatopsyche*, the amphipod *Hyaella azteca*, and the whirligig beetle *Dineutus*.

Quarterly Parkway Canal outflow. Biological oxygen demand was somewhat high, however (1.5 mg/L), probably due to decaying organic matter in the canal.

The habitat assessment put the canal outflow in the suboptimal category (113 out of 160 possible points) due to low substrate availability and water velocity coupled with considerable silt smothering of aquatic habitats.

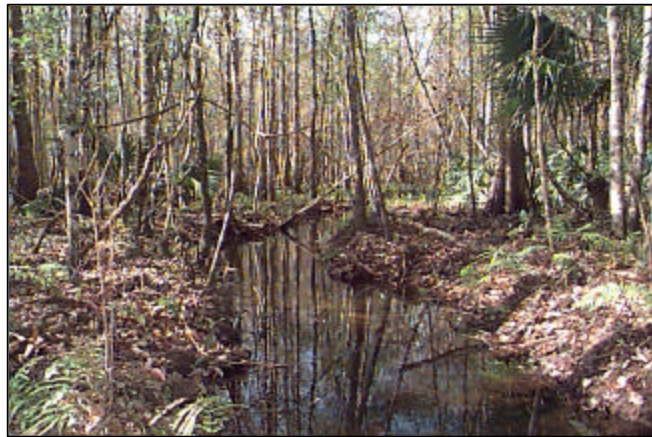
Located about 1.7 miles north of Quarterly Parkway Canal, Nettleton Canal enters the Econ a short distance downstream of where a natural tributary, Cowpen Branch, flows into the river from the west. The outflow from the canal is longer than that of Reynolds, and, like the other two, forms a longer, more natural-appearing stream as it winds its way to the Econ. A power line and easement parallels the north bank of the canal, crossing the river and continuing westward toward Orlando.

This site tied with the Econ River upstream of Quarterly Parkway Canal for the highest number of different macroinvertebrates found at a given site in the survey. Twenty-eight different taxa were found in the biorecon. This number included seven from the EPT group. The Florida Index score of 19 points was also quite high. The most abundant taxa in the sample were the damselfly *Argia sedula*, the mayfly *Stenacron interpunctatum*, and the caddisfly *Cheumatopsyche*.

All water chemistry results were good at this site. All nutrients, metals, bacteria, and physical-chemical values were in the low to medium range. Habitat assessment results were also quite good, with a score of 126 out of 160 possible points (79%).

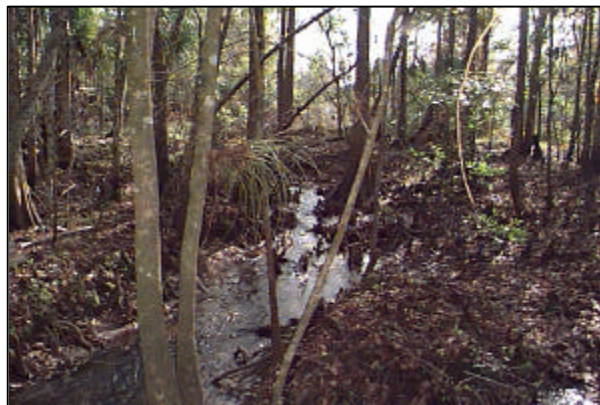
Northernmost of the four canals monitored in this survey is Majestic Parkway Canal, which lies on the northern edge of the Wedgewood development. It also did well in the biological assessment. There were 26 different macroinvertebrate taxa collected. Seven of these were

from the EPT group (5 caddisflies and 2 mayflies). The Florida Index score was 18. One especially interesting macroinvertebrate collected was the larva of the caddisfly *Ceraclea spongillovorax*, which is a commensal within the freshwater sponge *Spongilla*. These sponges, which adhere as small patches or clumps on sunken logs and sticks in lower velocity darkly tannic streams, were collected at most of the sites in this area.

The results of water chemistry analyses were good on almost all counts. Low to moderate levels of nutrients, metals, and coliform bacteria were found. Physico-chemical measurements

were normal. The zinc concentration in the water, however, was quite high: 21.0 µg/L in January and 25.5 µg/L in July. Although not violations of Class III water quality standards, these levels are well above those found in 80% of Florida's streams. The source of zinc in this stream is not known at this time. Based on the biological results, however, it does not appear to have negatively affected the ecological health of this water body, at present.

The Majestic Parkway Canal outflow did well on the habitat assessment, receiving a score of 127 out of 160 possible points, or 79%.

The source of the high zinc concentrations in the canal is not known. However, it does not appear to have had any obvious negative effect on the health of the river, since this was the only site in this survey at which zinc concentrations were especially high, and the health of the macroinvertebrate community present in the canal itself was quite good.

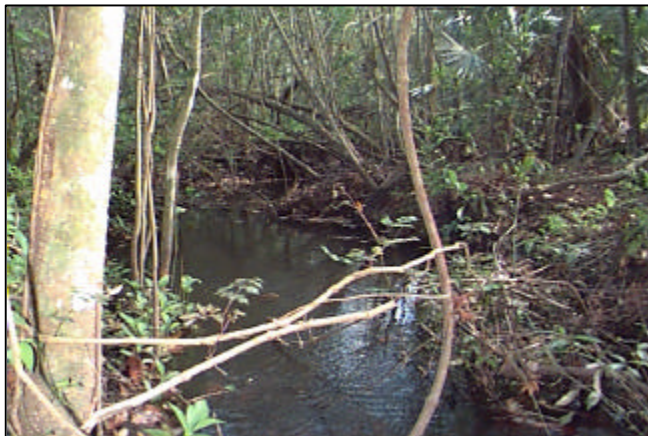
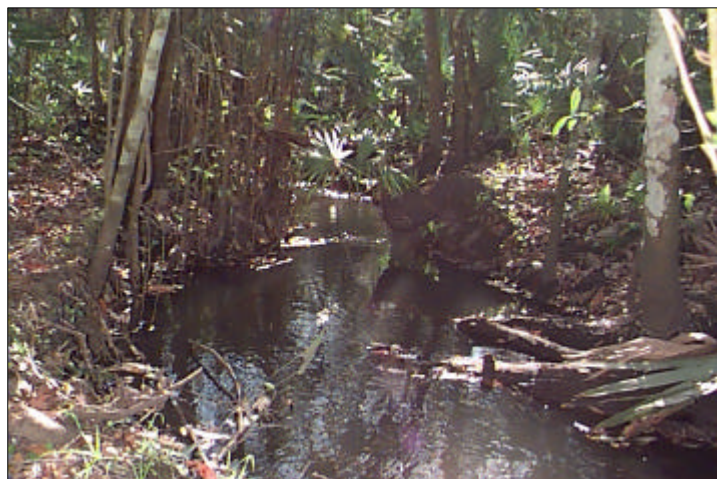
This natural tributary of the Econlockhatchee arises in wetlands near the intersection of state roads 50 and 520, flowing westward into the river just south of the town of Bithlo. It has for some time been characterized by poor water quality, and is listed on the state's 303(D) list for possible TMDL study. We sampled Long Branch where it crosses under CR 13S.

The biorecon assessment rated this site as “impaired” on both sampling dates, based on the scarcity of water quality sensitive macro-invertebrate taxa that survive here. Twenty-one aquatic invertebrate taxa were found at Long Branch in January, and 32 in July. On both occasions, however, only three of these were from the water quality-sensitive EPT group. In two instances only one individual of one of these EPT taxa was found in the four sweeps. The Florida Index score was 9 in January and 8 in July. Similar results were found here with a January 1998 biorecon.

Water chemistry results were consistent with biorecon results. Turbidity, phosphorus, and ammonia levels were high on one or both sampling dates. Elevated levels of lead were found in January. Fecal and total coliform bacteria were present at high concentrations on both sampling dates.

Long Branch did relatively well on the habitat assessment, despite its substantial water quality problems. The effect of extensive silt smothering on aquatic habitats and low water velocity coupled with a scarcity of some habitat types did count against it somewhat. The habitat assessment score was 119 out of a possible 160 points, or 74%.

As mentioned earlier, Long Branch is being evaluated for an intensive TMDL (total maximum daily load) study, which should further identify the sources of pollution in the watershed, and hopefully elucidate remediation alternatives.

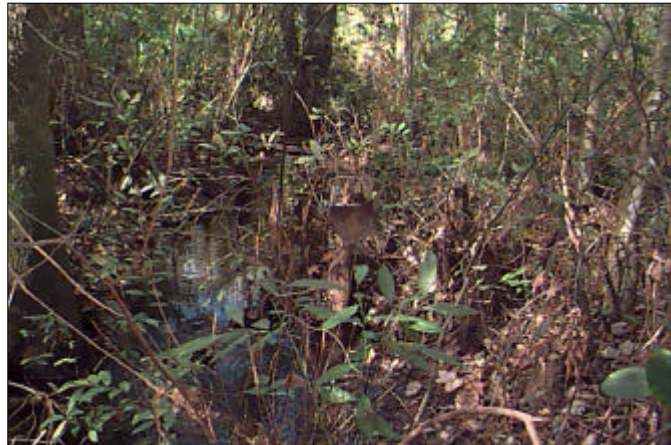
Bithlo Branch at Old Cheney Highway (Old SR 50)

Originating in small wetland ponds in the northern part of Bithlo, this very small, shallow, possibly intermittent tributary flows into the Econ from the northeast just downstream of where Long Branch enters. The bioassessment gave Bithlo Branch a marginal “healthy” rating in January, and a “suspected impaired” rating in July. Twenty and twenty-three macroinvertebrate taxa were collected, respectively. Five were from the EPT group in January, and 4 in July. The Florida Index score was 11 in January, but only 3 in July.

Water chemistry sampling yielded low to normal values for all nutrients and metals tested. Physicochemical parameters were within normal levels, also. Coliform bacteria levels, however, were high in January and extremely high in July. January sampling showed a fecal coliform concentration of 217 colonies/100mL and a total coliform concentration of 1000 colonies/100mL. These values are in approximately the 80th percentile compared to other Florida streams. These levels were substantially less, however, when compared to July, at which time both fecal and total coliform bacteria concentrations were **2600 colonies/100mL**. Both are violations of Class III water quality standards.

The habitat assessments showed different results for the two sampling dates. In January, the site received a score of 133 out of 160 points, placing it in the optimal category. In July, however, the score was a suboptimal 104, due to low flow, extensive habitat smothering, and a scarcity of aquatic habitat types.

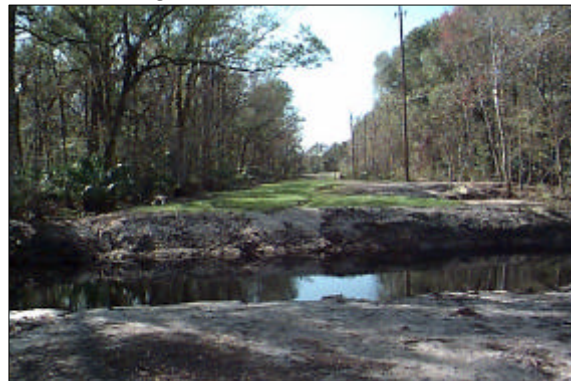
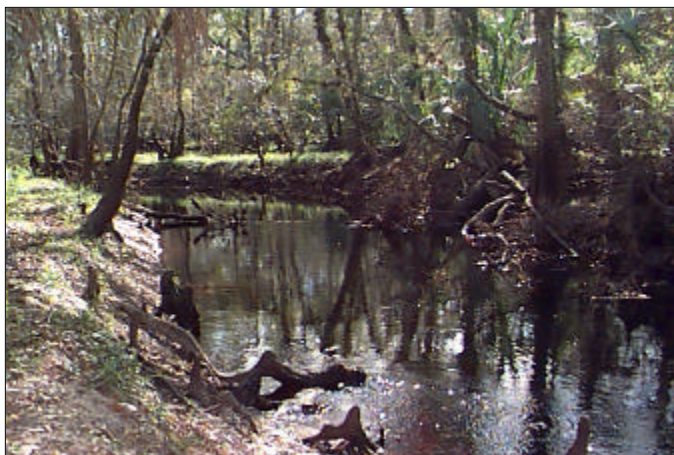
Econlockhatchee River at Old Cheney Highway

Approximately 2 miles downstream of the confluence of Long Branch with the river is the next sampling site. Old Cheney Highway (Old SR 50) formerly crossed the river at this location, but the bridge was removed some time ago. Very recently (since this sampling was carried out in 1999), the old bridge abutments and roadway have been removed, returning the area to a topographic level similar to the surrounding floodplain (see photo at right). The actual sampling location is approximately 50 m upstream of this clearing (photo below).

The bioassessment carried out in January 1999 indicated a healthy aquatic community. Of the 25 macroinvertebrate taxa collected, there were 7 EPT (4 caddisflies and 3 mayflies). The Florida Index score was 18. Thus, all three bioassessment target thresholds were passed.

Water chemistry results were mixed. Although there were no extremely high values reported, some nutrient values (*i.e.* AGP, phosphorus, nitrate/nitrite, and TKN) were slightly to moderately elevated during the July sampling, as was BOD. Coliform bacteria levels were high in July, as well. Fecal coliforms were present at a concentration of 490 colonies/100 mL, and total coliforms were too numerous to count in the sample.

Habitat assessment results were good. The site scored 128 out of 160 possible points, or 80%. Less-than-optimal substrate diversity and availability, plus low water velocity and habitat smothering reduced the habitat score somewhat from what it would otherwise have been.

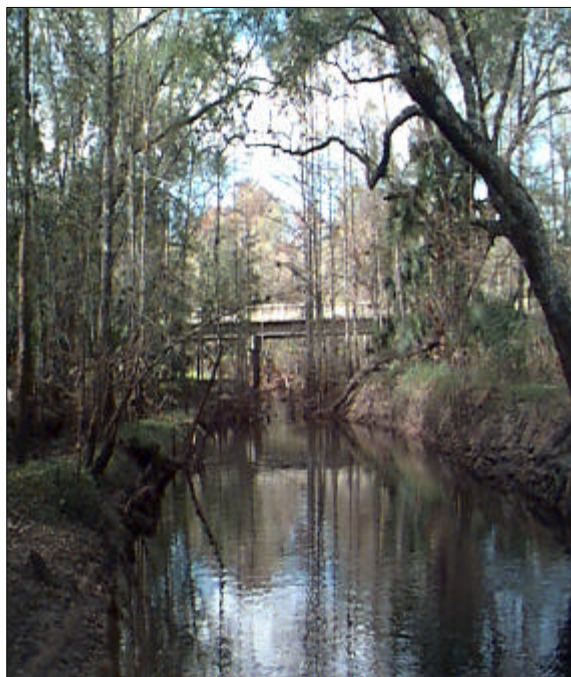
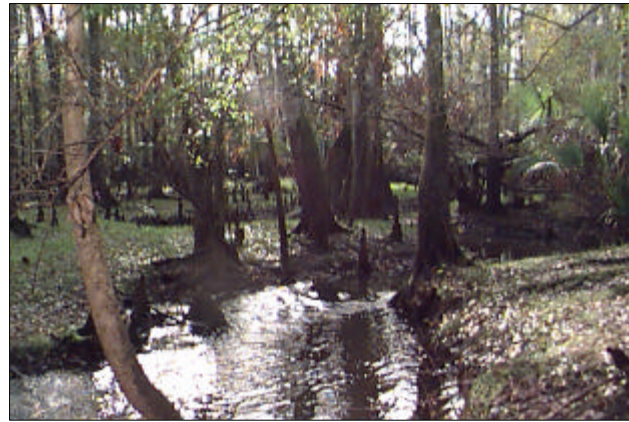
Econlockhatchee River at SR 420

Located just over a mile downstream of SR 50, this stretch of the river has served as a biological reference site for FDEP biologists since 1992. Biological and water chemistry samples taken over the past 8 years have consistently shown good water quality and ecological health. The results of the 1999 sampling reveal similar results.

There were 24 different macroinvertebrate taxa found in the biorecon carried out in January. Six of these were from the EPT group (3 mayflies and 3 caddisflies). The Florida Index score was 12. The most common invertebrate found in the sample was the water mite *Arrenurus*. The biorecon ranked the site as healthy.

Water chemistry results were mixed. Whereas the concentrations of the various metals sampled for were low, several nutrient levels were somewhat high in the summer sampling, as were coliform bacteria levels. AGP, total phosphorus,

nitrate/nitrite, Kjeldahl nitrogen, and biochemical oxygen demand were slightly to moderately elevated in the Econ at SR 420. Fecal coliform levels were elevated on both occasions (417 and 340 colonies/100mL in winter and summer, respectively), and total coliforms were high (1500 colonies/100mL) in July.

Another parameter of concern at this site is turbidity. In the winter, the turbidity level was 12 NTU (>80th percentile). In the summer, it was 4.3 NTU, which is still somewhat above the average. A likely source of this turbidity is an unnamed tributary that flows into the river from the

west approximately 85 m upstream of the SR 420 bridge. A rapid flow of water from this stream can be seen discharging into the river at all parts of the year, often with a sediment plume apparent at the confluence. Although not a part of this survey, we sampled this tributary (pictured at right) for biology in early February 2000. Despite its apparent turbidity problems, the biorecon indicated that the macroinvertebrate community was essentially healthy. Coliform bacteria levels were low.

We think that further study is needed regarding the effect of the unnamed tributary near SR 420 on the health of the Econ, and the source(s) of degradation. Given this information, recommendations for the improvement of the situation should become evident.

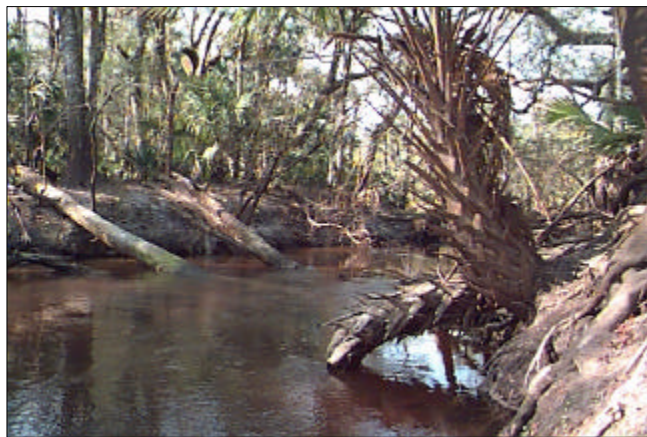
Little Econlockhatchee River just upstream of Econlockhatchee River

This site is located approximately 50 m upstream of where the Little Econ flows into the Big Econ near SR 419 at Oviedo. At this point, the volume of water in the Little Econ generally

matches that of the Big Econ. Historically, the water quality of the Econ has shown an immediate decline downstream of this confluence due to point source inputs from wastewater treatment plants (all but one, the Iron Bridge WWTP, are now off-line) and a tremendous amount of stormwater runoff into the Little Econ from the Orlando area.

Water chemistry samples showed elevated levels of several nutrients (high algal growth potential, phosphorus, ammonia, and nitrate/nitrite) on both sampling dates, as

well as copper and nickel in January. Coliform bacteria levels were higher than average for Florida streams in both winter and summer, but no violation of standards was seen. All other measured physical and chemical parameters were within normal ranges.

Biological sampling indicated that the water quality in the Little Econlockhatchee is sufficient to support a fairly robust macroinvertebrate community. The biorecon gave the stream a healthy ranking. There were 19 different taxa collected, including 3 mayflies and 5 caddisflies (EPT = 8). The Florida Index score was a respectable 18 points. Good habitat helped support this assemblage. The habitat score was 125/160 points, or 78%.

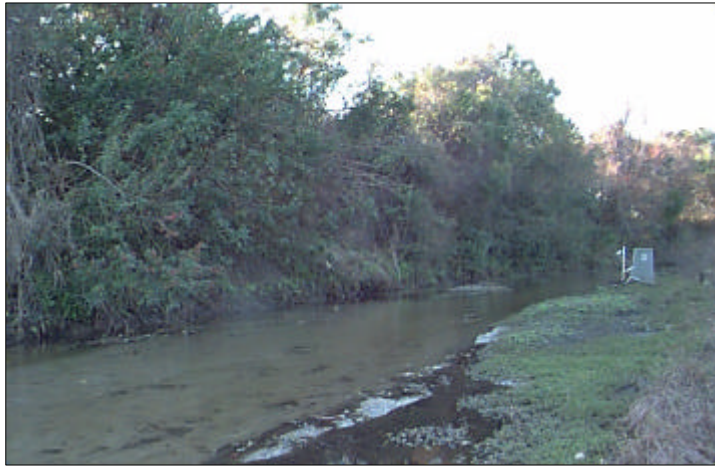
Crane Strand at University Boulevard

This canal is one of the larger tributaries of the Little Econ River. Recent FDEP sampling has indicated poor water quality in Crane Strand (FDEP 1996). In earlier days, Crane Strand existed as a stream connecting several wetland areas. Quite a few years ago, however, the stream was canalized to serve as a conduit for stormwater and effluent from two wastewater treatment plants to the Little Econ. Even though neither of the two plants discharges into Crane Strand today, the canal still receives large quantities of non-point source runoff. We sampled the canal at its approximate halfway point, at University Boulevard in Orlando.

Poor habitat and undesirable water quality combined to give meager biological results. A biorecon was performed on both dates. In each instance, the assessment rating was “impaired”. Fifteen taxa were collected in January. Only one EPT organism, the mayfly *Caenis diminuta*, was present. The Florida Index score was 3. July’s results were not much better. Although there were 24 macroinvertebrate taxa collected, only two were in the EPT group, and the Florida Index score was only 2.

Predictably, habitat assessment scores were also low. On both occasions, the habitat scores fell in the poor range, with 46/160 (29%) in January and 69/160 (43%) in July. Higher scores in the latter assessment were due to larger amounts of habitat (*i.e.* aquatic vegetation) present in July than in January.

Nutrient concentrations were quite high in Crane Strand Canal in winter and summer. Metals were low in all cases, with the exception of lead, which was somewhat high in January. Coliform bacteria concentrations were not especially high in January, but were extremely elevated in July, when fecal coliforms were present at a level of 1300 colonies/100 mL and total coliforms were TNTC (too numerous to count) in the sample. The fecal coliform and most likely total coliform values represent violations of water quality standards.

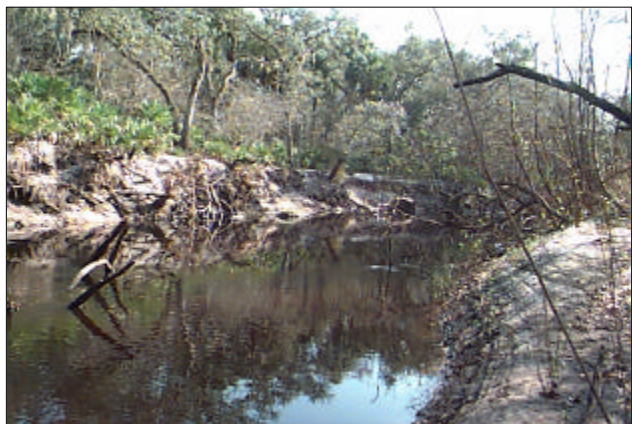
Econlockhatchee River at SR 419

Located a short distance downstream of the confluence with the Little Econ, this site is the first

in the survey which shows the effects of the Econ’s largest tributary on the main river. Beyond this point, however, there are few sources of pollution to the river, since from here to the St. Johns it flows through undeveloped land, cattle ranches, and public property.

As might be expected, nutrient levels increased substantially at this site in the Econ compared to sites farther upstream. Nutrient

input from the Little Econ was manifested in similar nutrient increases in the Big Econ. As in the Little Econ, AGP, total phosphorus, ammonia, and nitrate/nitrite measurements were all elevated. Metals and coliform bacteria concentrations, however, were within normal ranges, with the exception of the summer sampling, when total coliforms were present in the Big Econ at a level of 900 colonies/100 mL, or about the 75th percentile compared to other Florida streams.

Despite some water quality problems, the biological health of the Econ at this point appears to be good. The biorecon gave it a healthy rating. There were 23 macroinvertebrate taxa collected, 10 of which are members of the EPT group (4 mayflies and 6 caddisflies). The Florida Index rating was 18, the same as in the Little Econ River. Good habitat quality and water velocity undoubtedly contributed to the good biological results. The habitat assessment score was 129/160 points, or 81%.

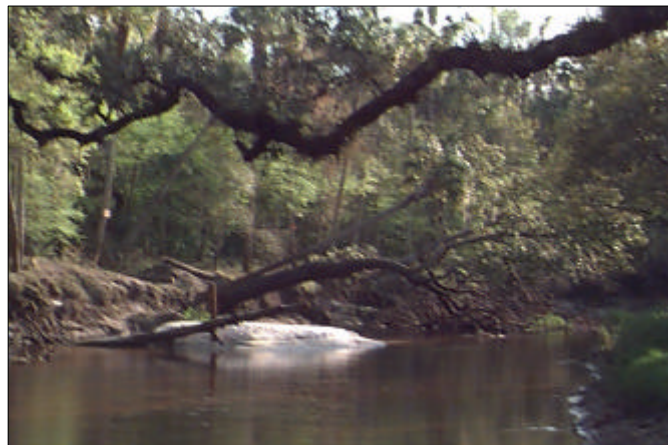
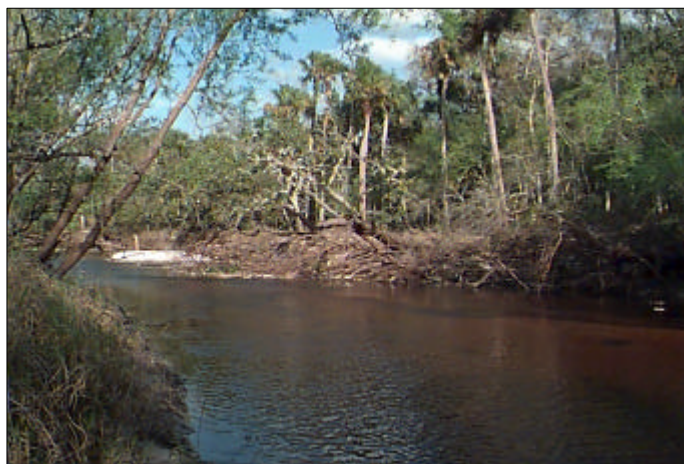
Econlockhatchee River at Snowhill Road

This site, approximately 5 miles upstream from the St. Johns River, is the farthest downstream location sampled in this study. At the sample site, the north bank of the river is part of the Little-Big Econ State Forest, and the south bank is private property. From here downstream to the St. Johns, the Econ flows primarily through privately held ranchlands. The state (SJRWMD) hopes to eventually acquire a substantial portion of this land. Unlike upstream areas of the Econ, the river here winds its way to the east through relatively high, rolling sandbanks on its way toward the St. Johns.

Water chemistry values demonstrate lasting effects from upstream nutrient inputs. Nutrient analysis results here were very similar to those seen in the Big Econ near SR 419 and the Little Econ just upstream of the Big Econ, with elevated levels of AGP, phosphorus, nitrate/nitrite, and ammonia. Concentrations of metals and coliform bacteria, however, were low to moderate in the Econ at Snowhill Road.

Biorecon assessment indicated very good ecological health. Twenty-five different taxa were collected. Six of these, including 2 mayflies and 4 caddisflies, were EPT taxa. This site received the highest Florida Index score in the survey, 20 points. At least two species collected here were found

The habitat assessment score was quite good: 130/160 points, or 81%.
