Lakes Management Report

Five Year Update

May 2009

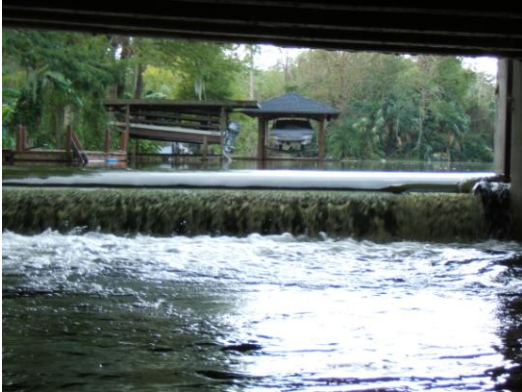
Chain of lakes outfall weir at Howell Branch Road.

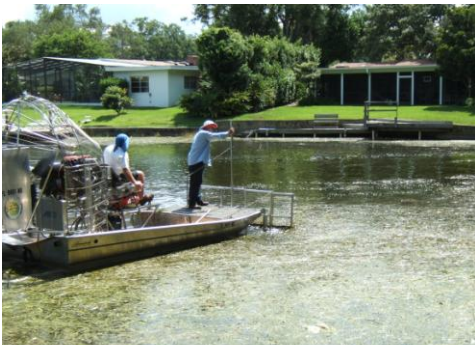
Airboat rake used to remove floating plants.

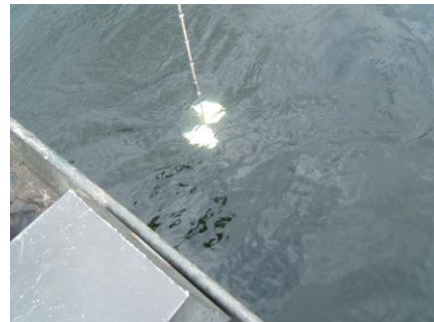
Secchi disk used to measure water clarity.

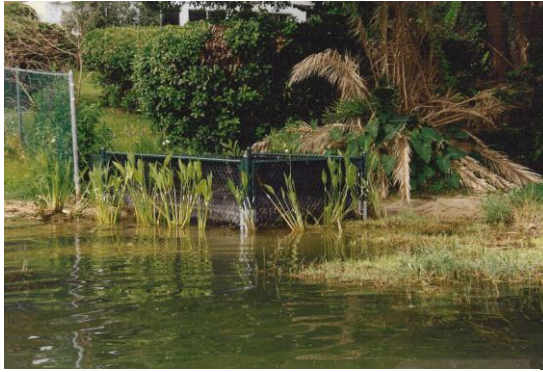
Stormdrain leaf traps prevent debris from entering our lakes

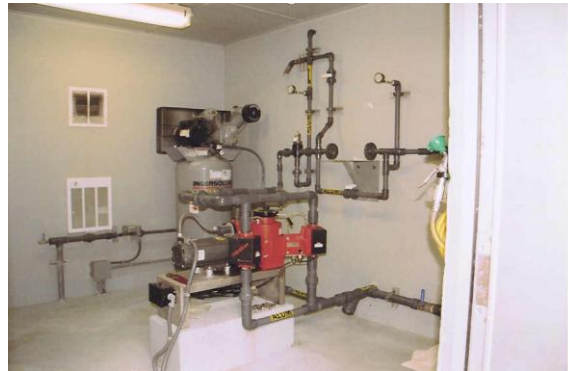
Mead Garden alum injection station

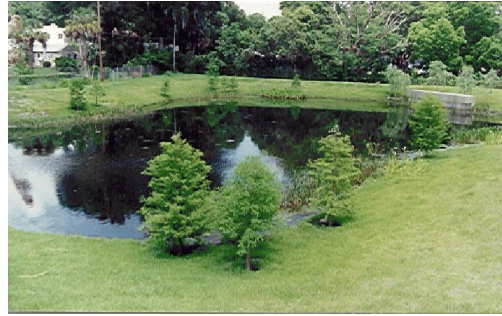
- **Traditional Retention or Detention Ponds** - Retention ponds hold all stormwater that enters. Water can only leave through percolation or evaporation. Detention ponds slow down water so that sediments can settle out, and algae and bacteria can breakdown other pollutants. Retention/Detention systems retain storms up to a certain volume, and then act as detention systems for volumes above the design amount.

Traditional wet retention/detention pond

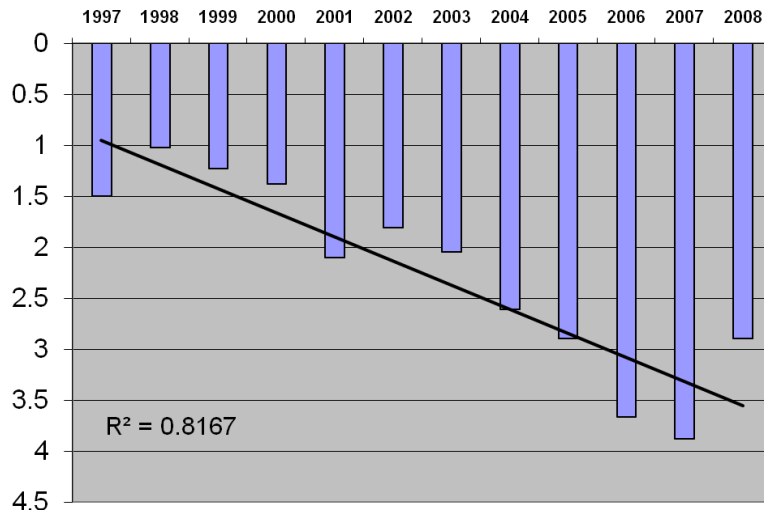
Figure 3-1. Lake Baldwin water clarity trend (meters)

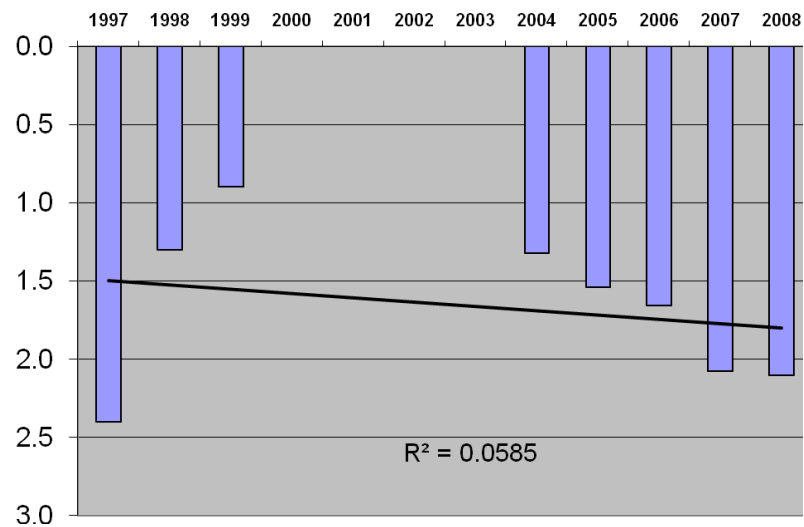
Figure 3-2. Lake Bell Secchi Disk Transparency (meters)

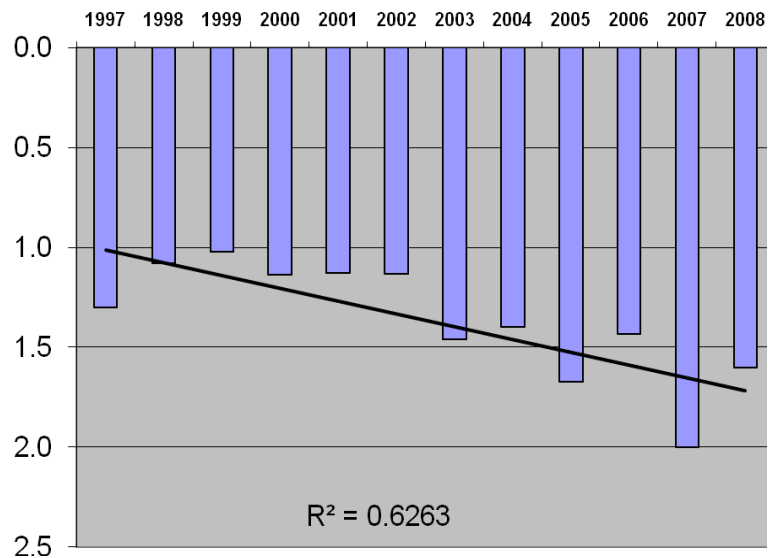
Figure 3-3. Lake Berry water clarity trend (meters)

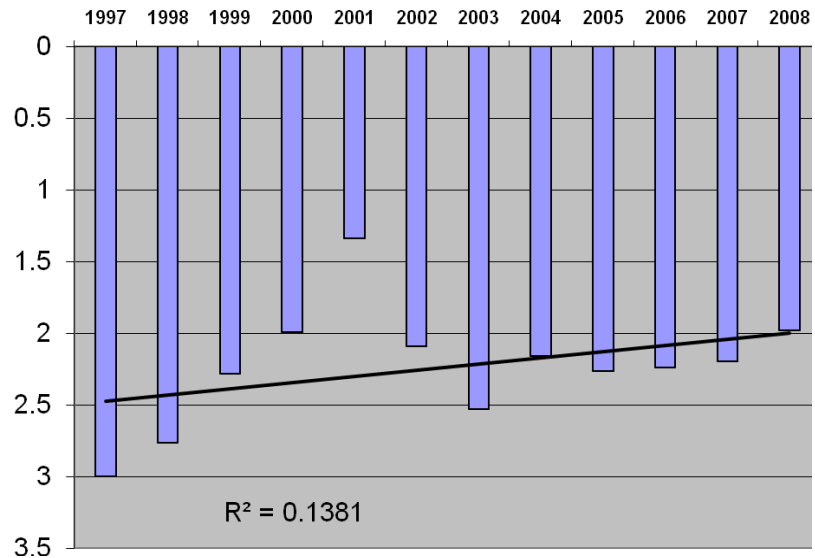
Figure 3-4. Lake Chelton water clarity trend (meters)

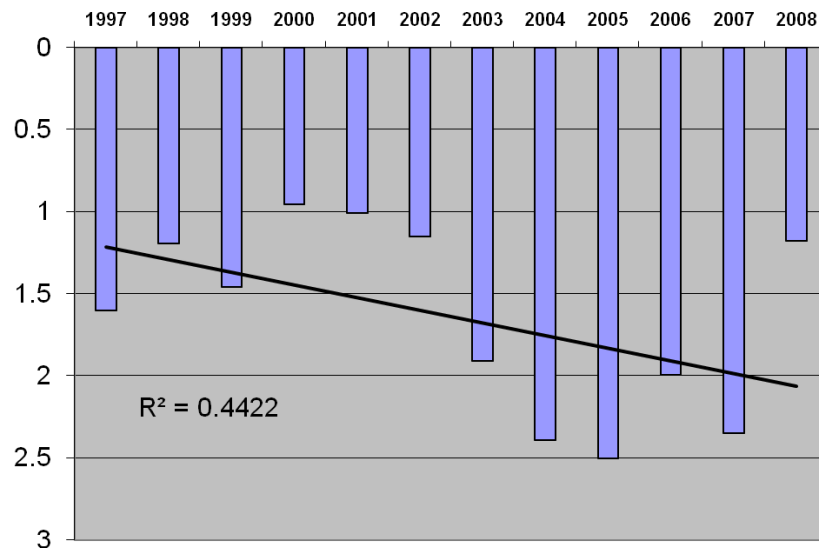
Figure 3-5. Lake Forrest water clarity trend (meters)

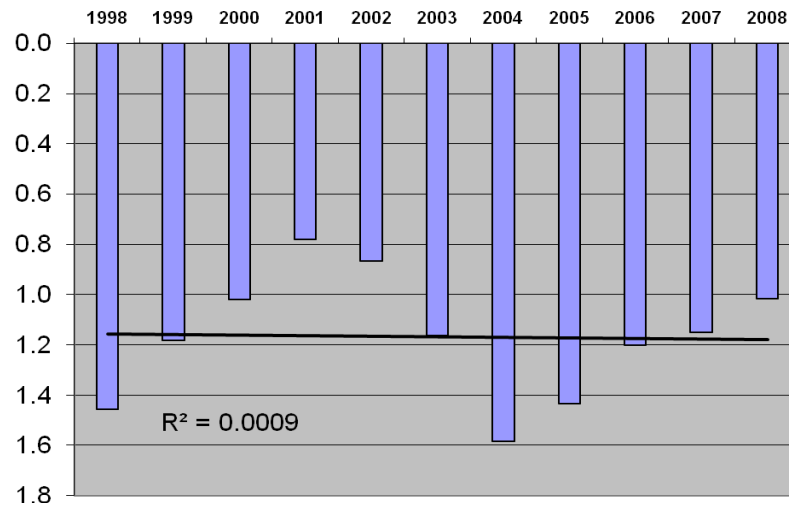
Figure 3-6 Lake Grace water clarity trend (meters)

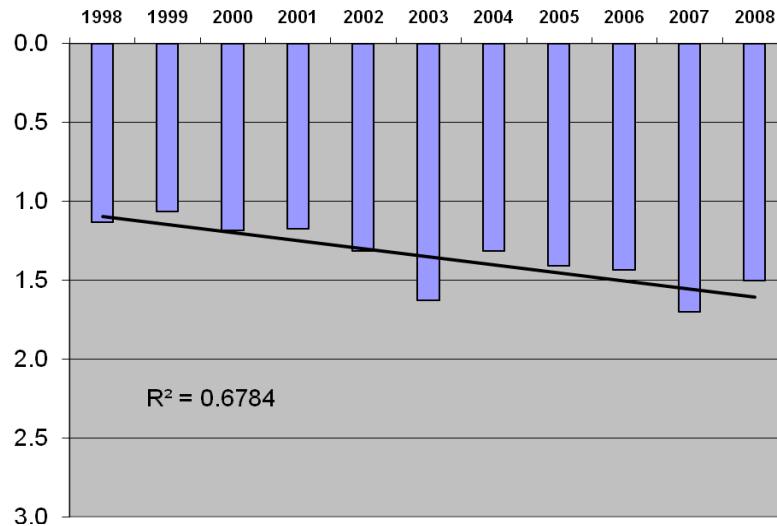
Figure 3-7. Lake Killarney water clarity trend (meters)

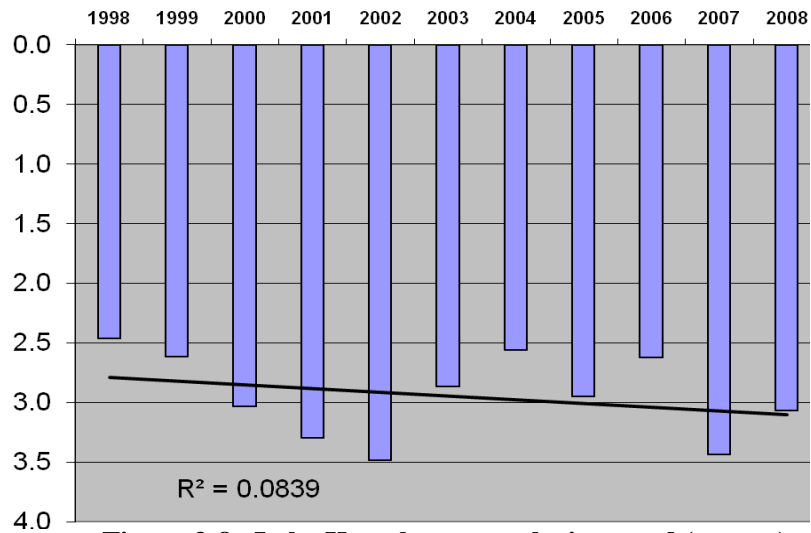
Figure 3-8. Lake Knowles water clarity trend (meters)

Water Quality: Water quality in Lake Knowles is primarily affected by stormwater runoff. Annual average Secchi disk transparency data (Fig. 3-8) from 1998 through 2008 show a consistent condition of good water quality over the ten year period.

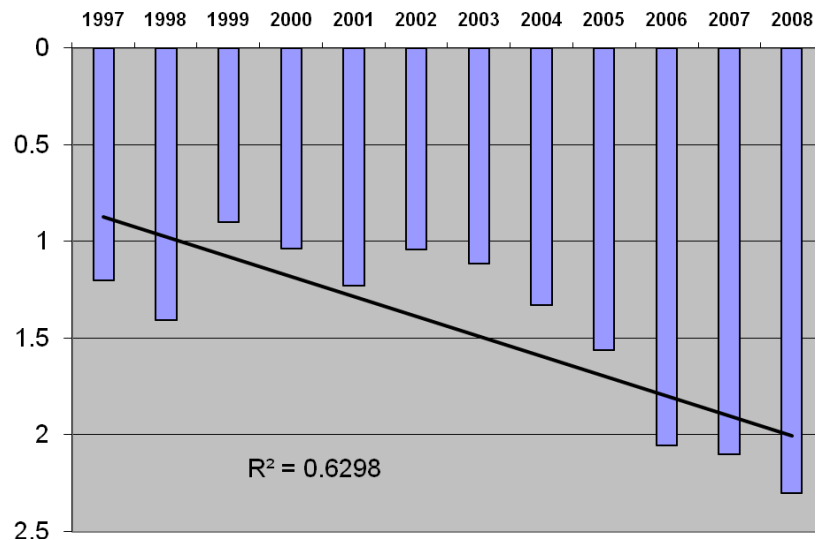
Figure 3-9. Lake Maitland water clarity trend (meters)

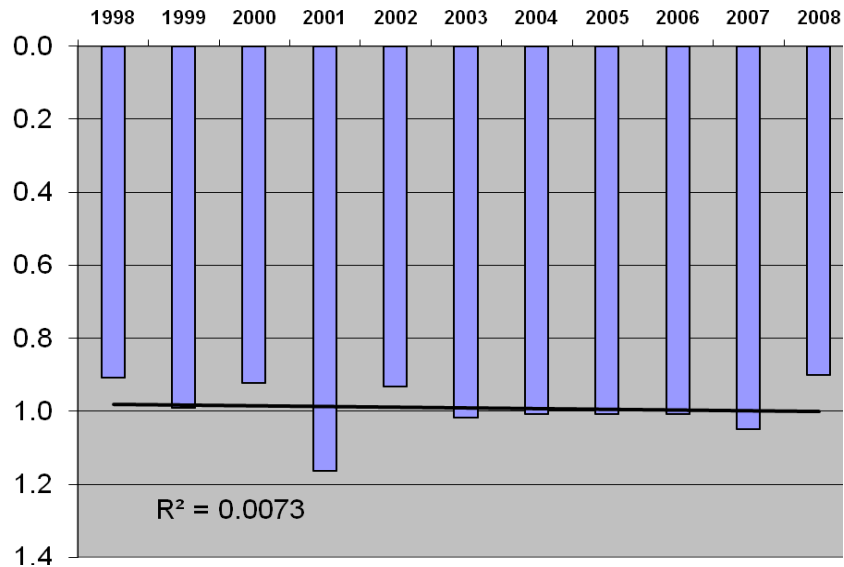
Figure 3-10. Lake Midget water clarity trend (meters)

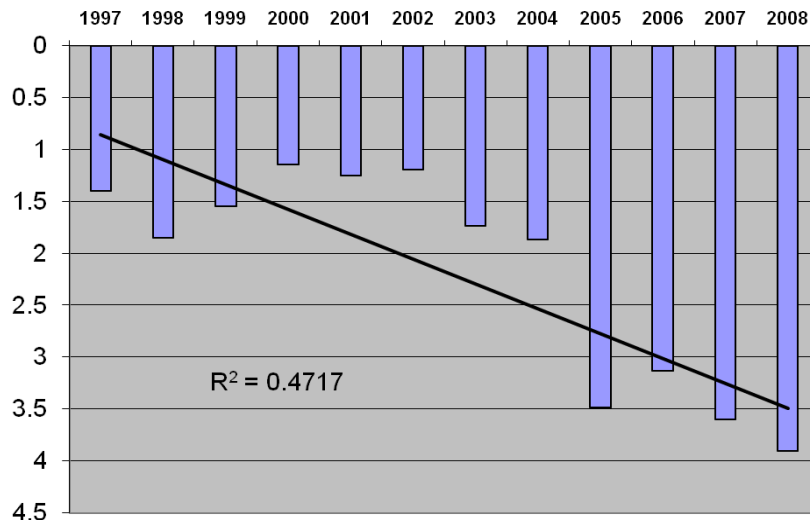
Figure 3-11. Lake Mizell water clarity trend (meters)

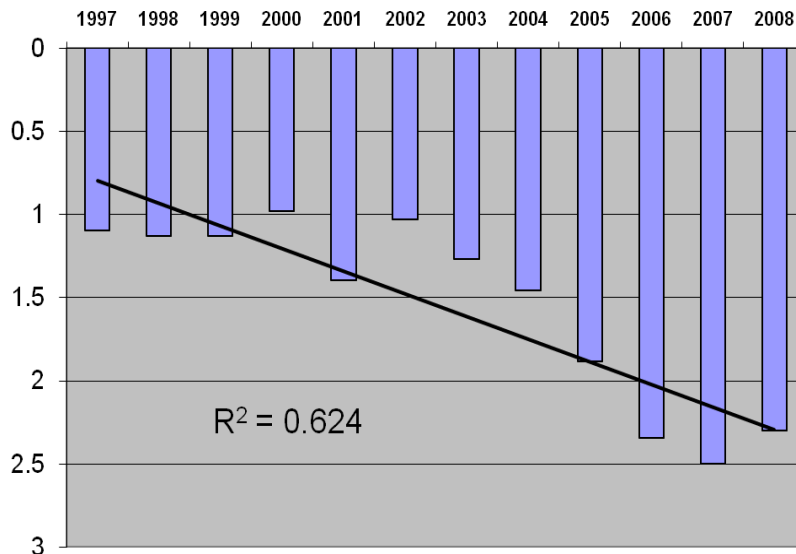
Figure 3-12. Lake Osceola water clarity trend (meters)

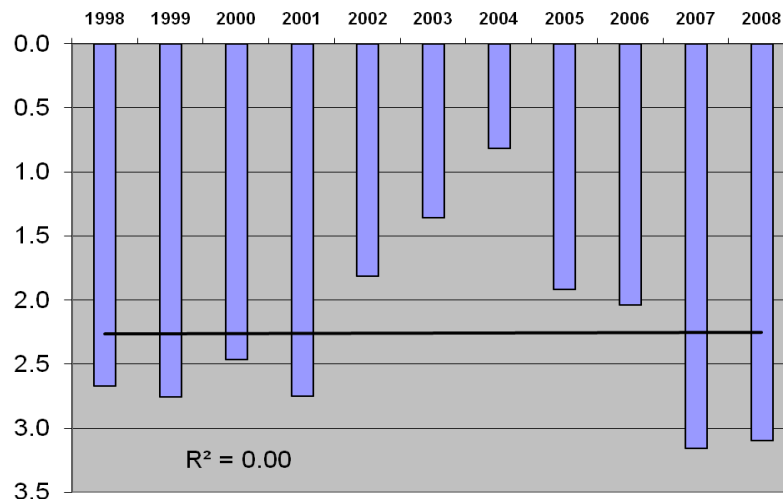
Figure 3-13. Lake Rose water clarity trend (meters)

Water Quality: Water quality in Lake Rose is primarily affected by stormwater runoff, but may also be influenced by groundwater sources since the lake is very deep. From 2002 to 2004, Lake Rose experienced a significant reduction in water clarity (Fig. 3-13). Diagnostic tests were run, but the cause of the decline was not determined. In 2005, the water clarity recovered, and continued to improve through 2008. Trend analysis for the period of record (1998 through 2008) shows no significant change in water clarity over that time.

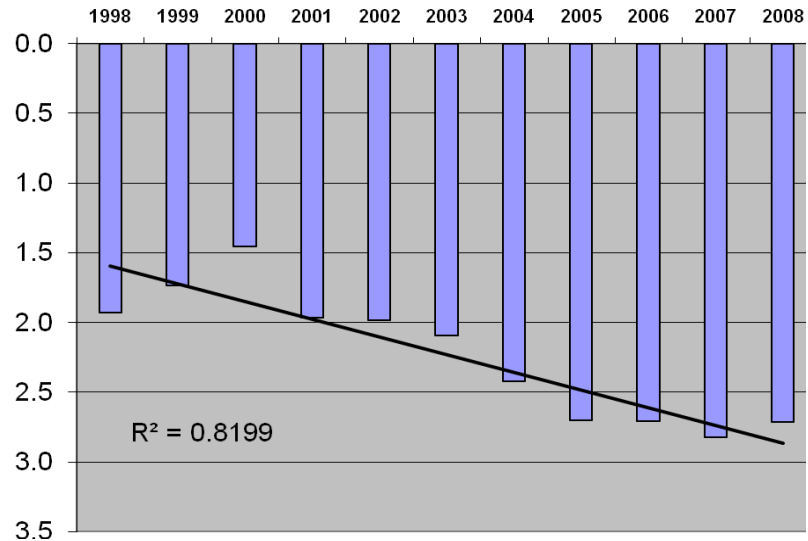
Figure 3-14. Lake Spier water clarity trend (meters)

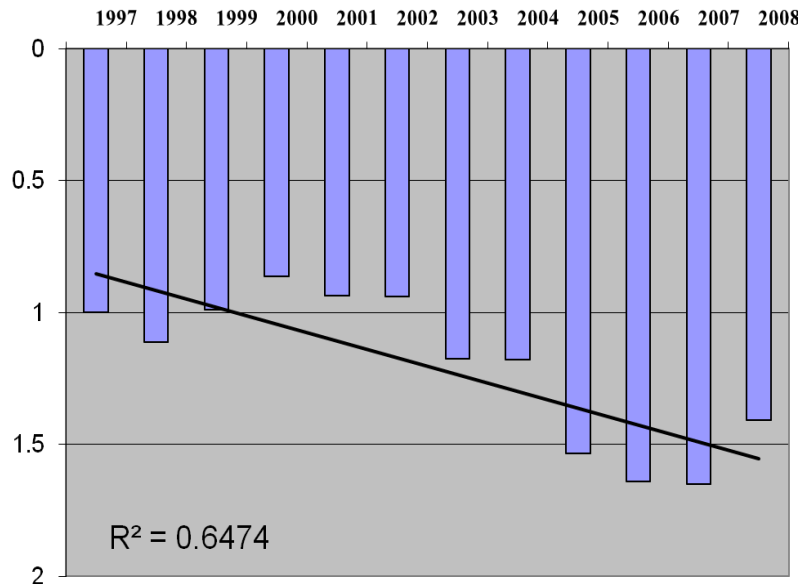
Figure 3-15 Lake Sue water clarity trend (meters)

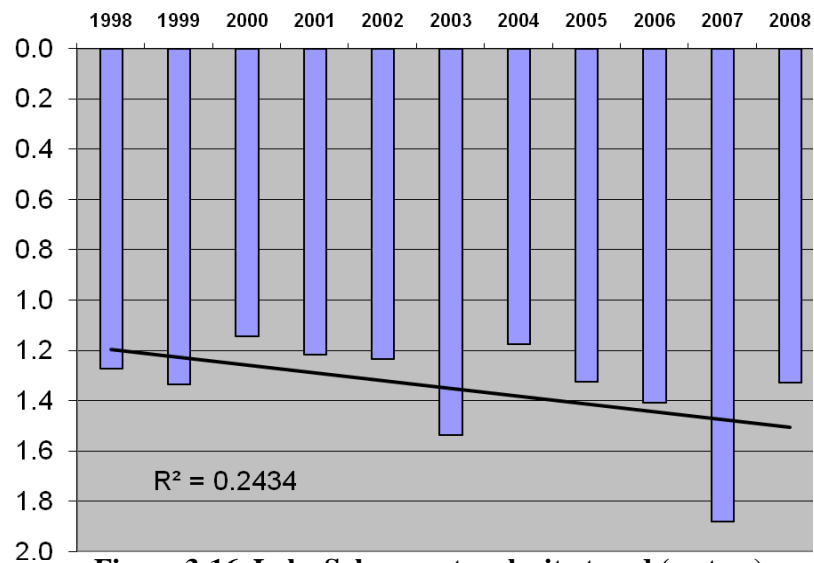
Figure 3-16. Lake Sylvan water clarity trend (meters)

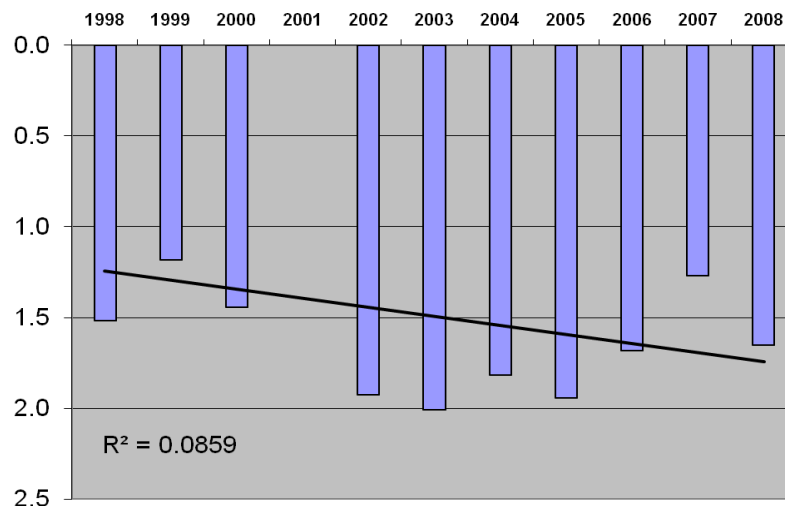
Figure 3-17. Lake Temple water clarity trend (meters)

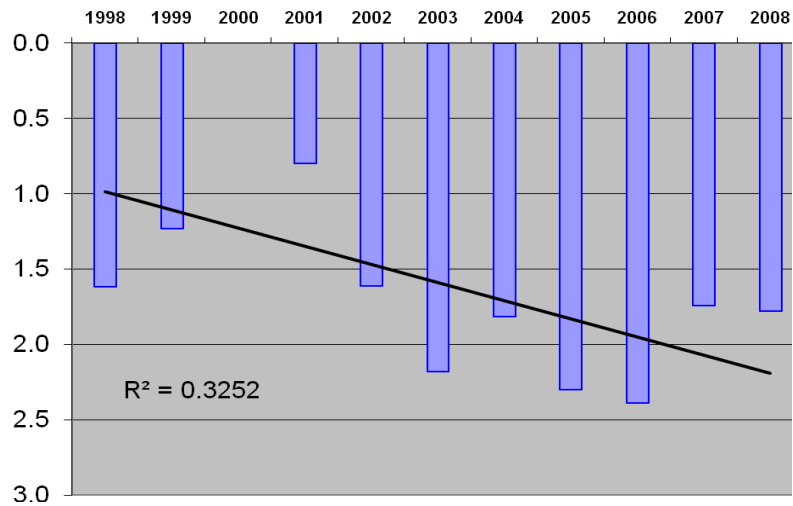
Figure 3-18. Lake Tuscany water clarity trend (meters)

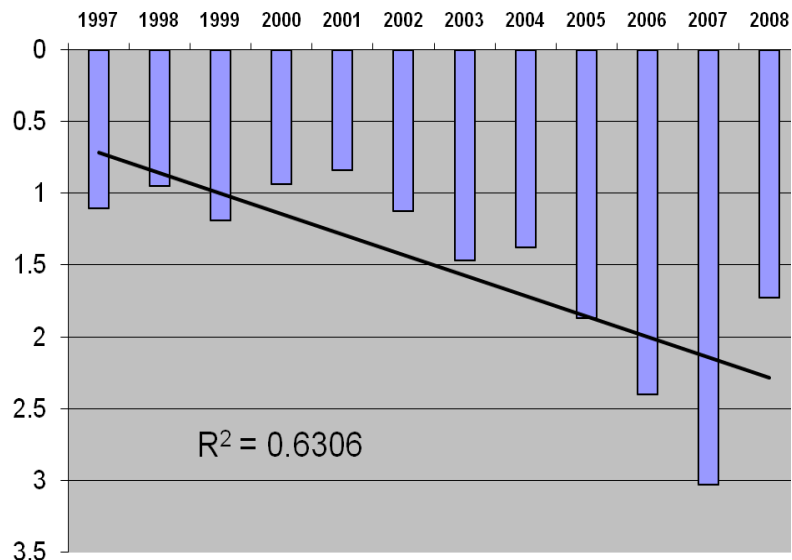
Figure 3-19. Lake Virginia water clarity trend (meters)

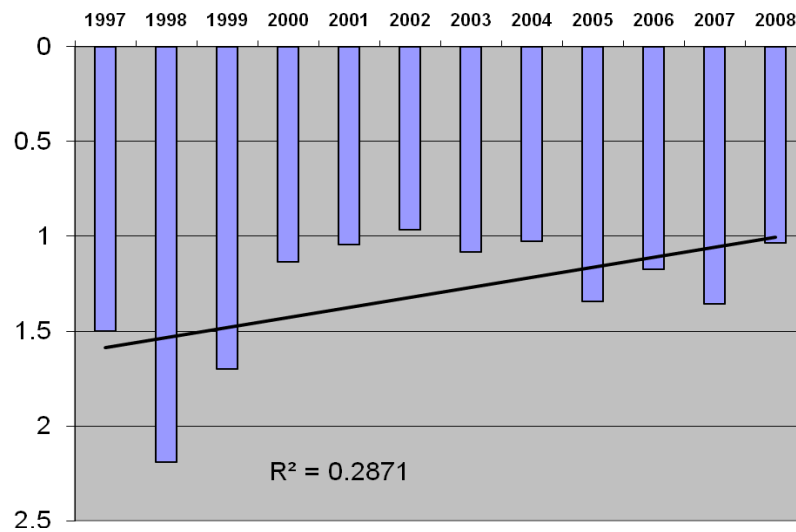
Figure 3-20. Lake Wilbar water clarity trend (meters)

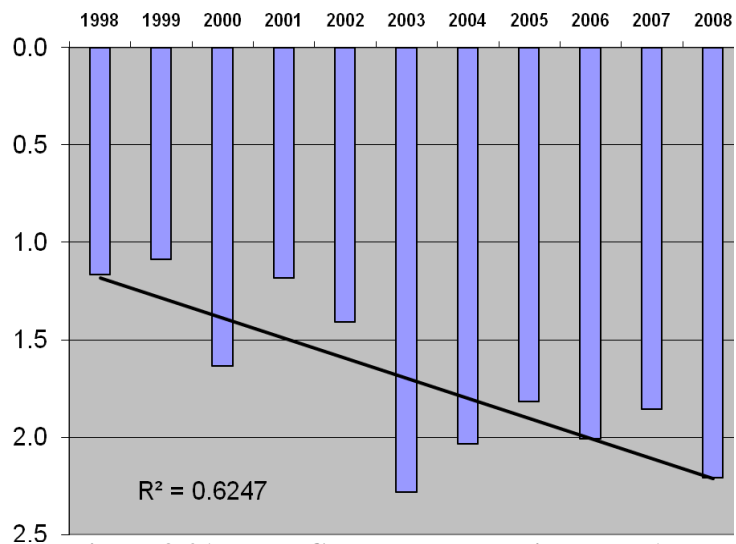
Figure 3-21. WPRC Pond water clarity trend (meters)

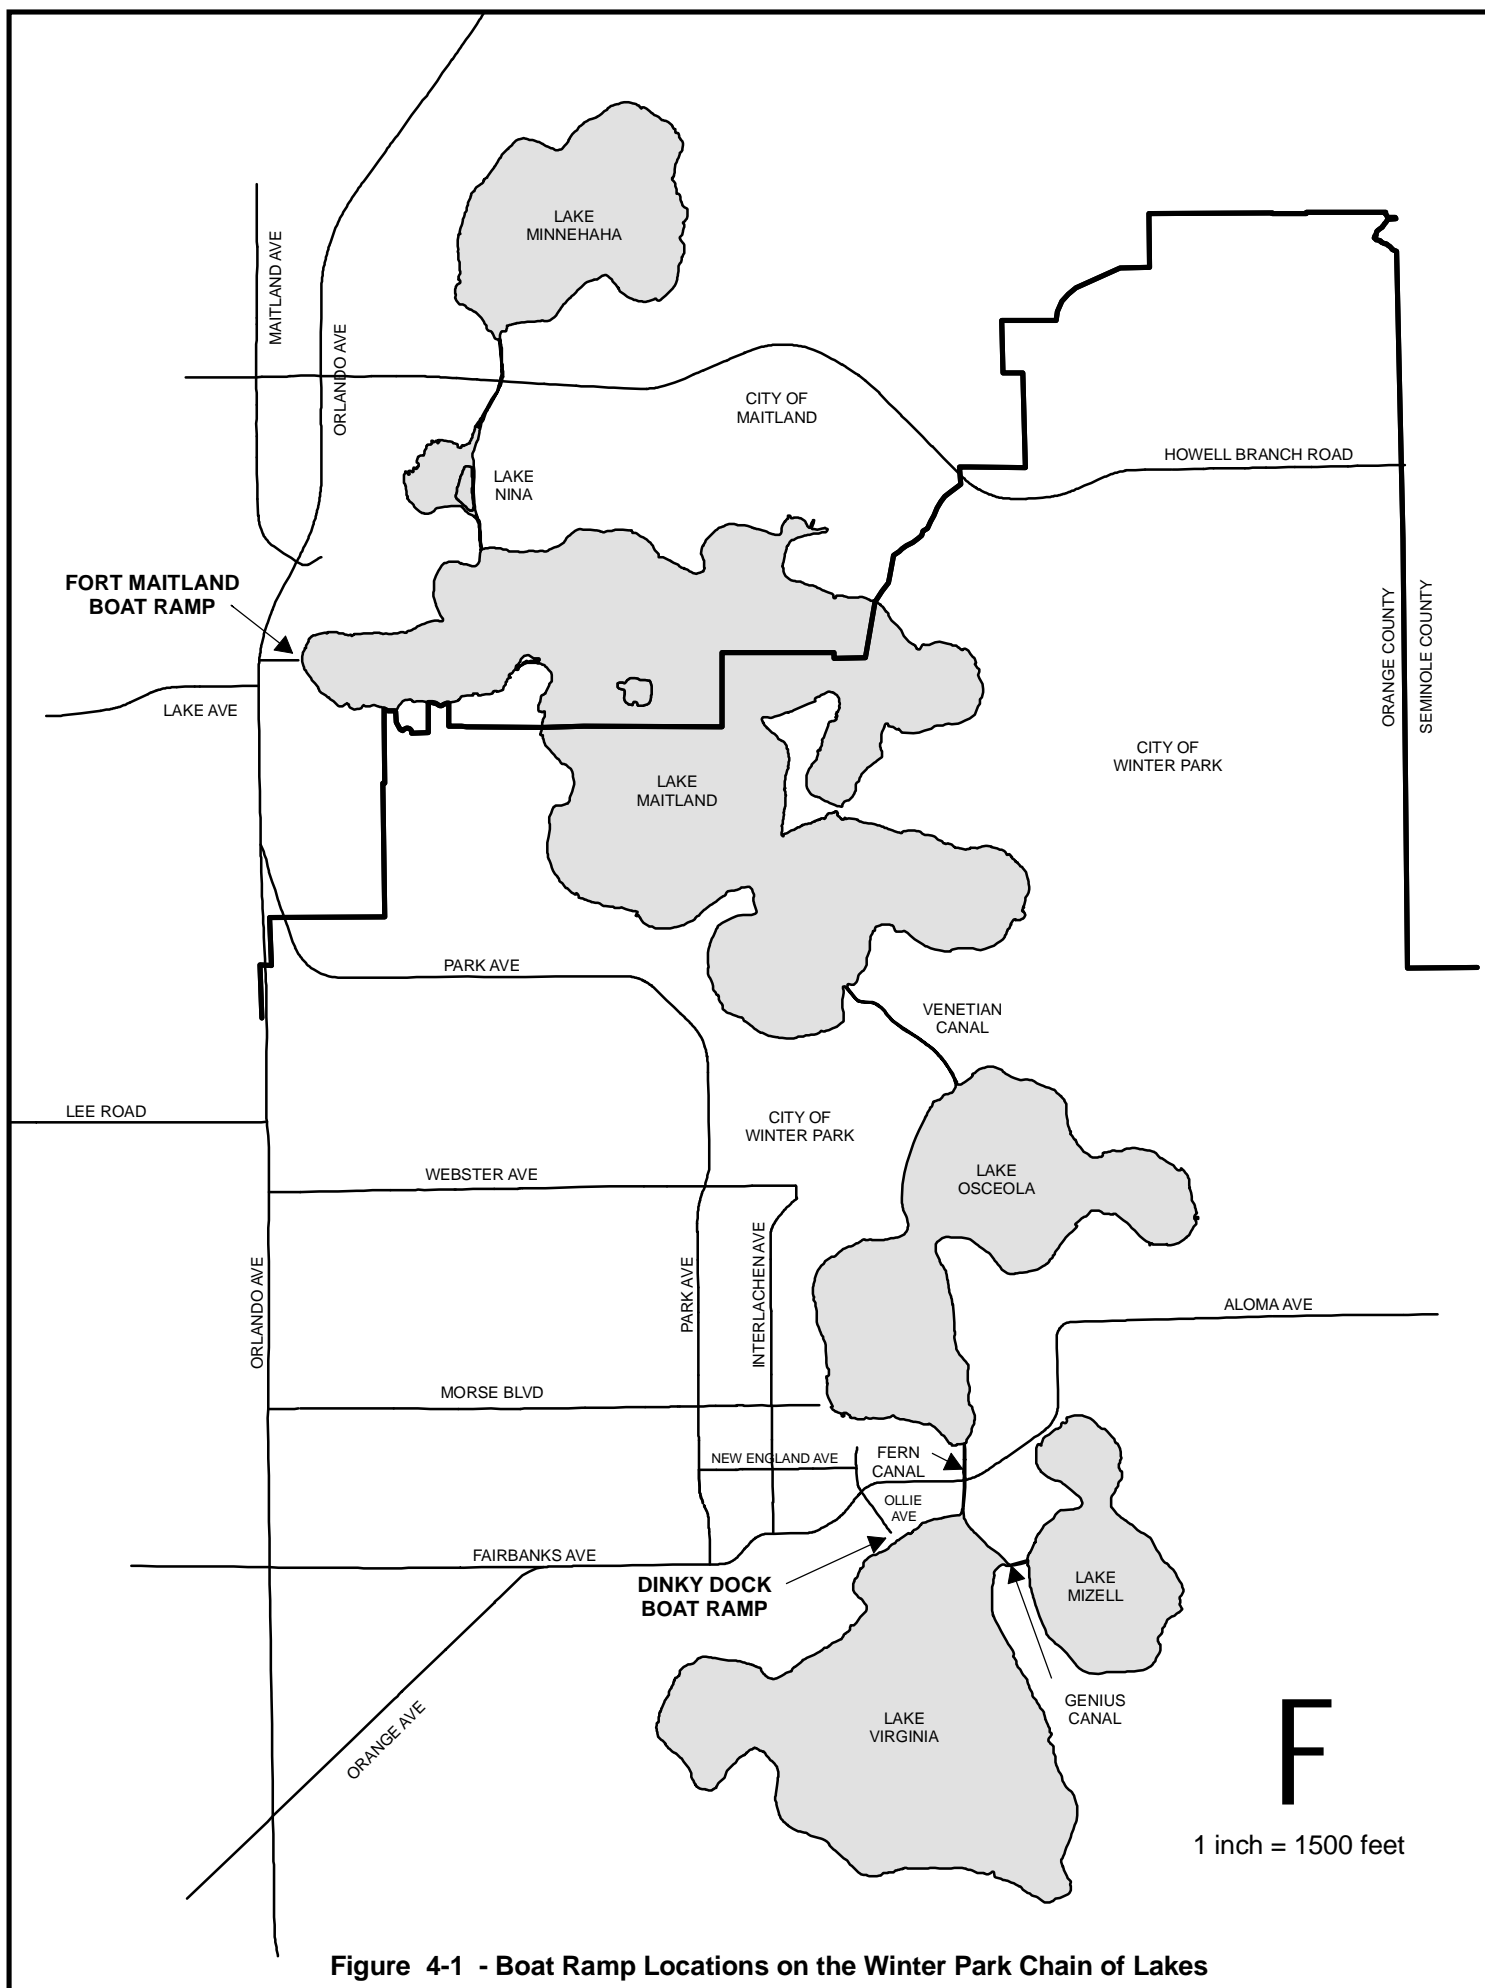
Figure 4-1 - Boat Ramp Locations on the Winter Park Chain of Lakes

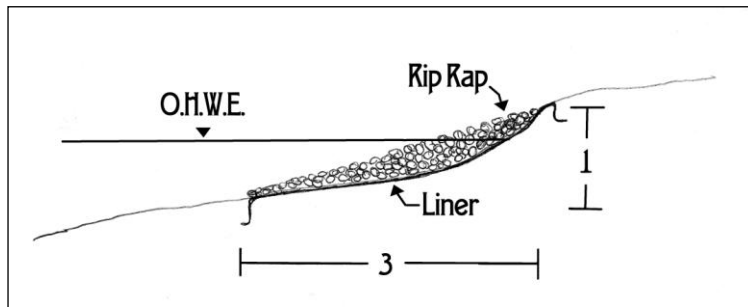
Shoreline revetments must have slopes no steeper than 3:1.

properties requesting permits to construct or repair seawalls or revetments must meet the current shoreline vegetation requirements as a condition of the permit. Vertical seawalls are not permitted, and property owners must demonstrate that an existing erosion problem is present before any revetment will be authorized.
