# BioView

## A Biological Snapshot of Lake Down June 9, 2006

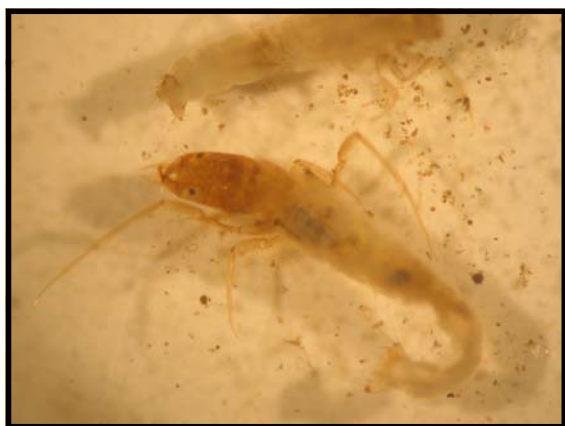
Fig. 2: Cernotina sp. found in Lake Down

The biological analysis of Lake Down suggests a very healthy macroinvertebrate community dominated by the Trichopteran genus, *Cernotina* (25%). Out of 104 organisms, 30 taxa were present. Only one Ephemeroptera taxa was found, *Hexagenia* sp. This order includes mayflies which are indicators of very good water quality and are sensitive to pollutants. The genus *Hexagenia* is a burrowing mayfly found in lake bottoms (Fig. 4).

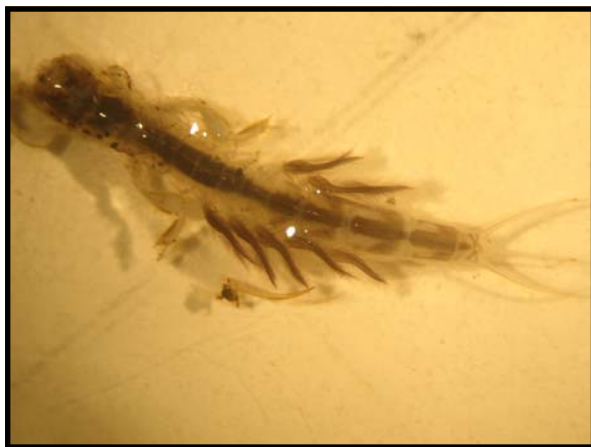
Fig 4: *Hexagenia* sp. found in Lake Down

And is an indicator of excellent water quality. They are sensitive to the amount of dissolved oxygen in the water body. The dominant taxa, *Cernotina*, is member of the order Trichoptera; commonly known as caddisflies.

Overall, the macroinvertebrate community of Lake Down showed good diversity with a Shannon-Wiener Diversity Index of 2.63. and Hulbert Index score of 13. Only 50% of the sample were identified to be in the Diptera order. Although there were only 3 EOT (Ephemeroptera, Odonata, Trichoptera) taxa, found, the mayfly *Hexagenia* sp. indicates that Lake Down is maintaining its very good water quality standings.
